1968 Ford Mustang

Summary

Inspection date: Jan 10 2024
CarAdvisors — Metro Atlanta, GA

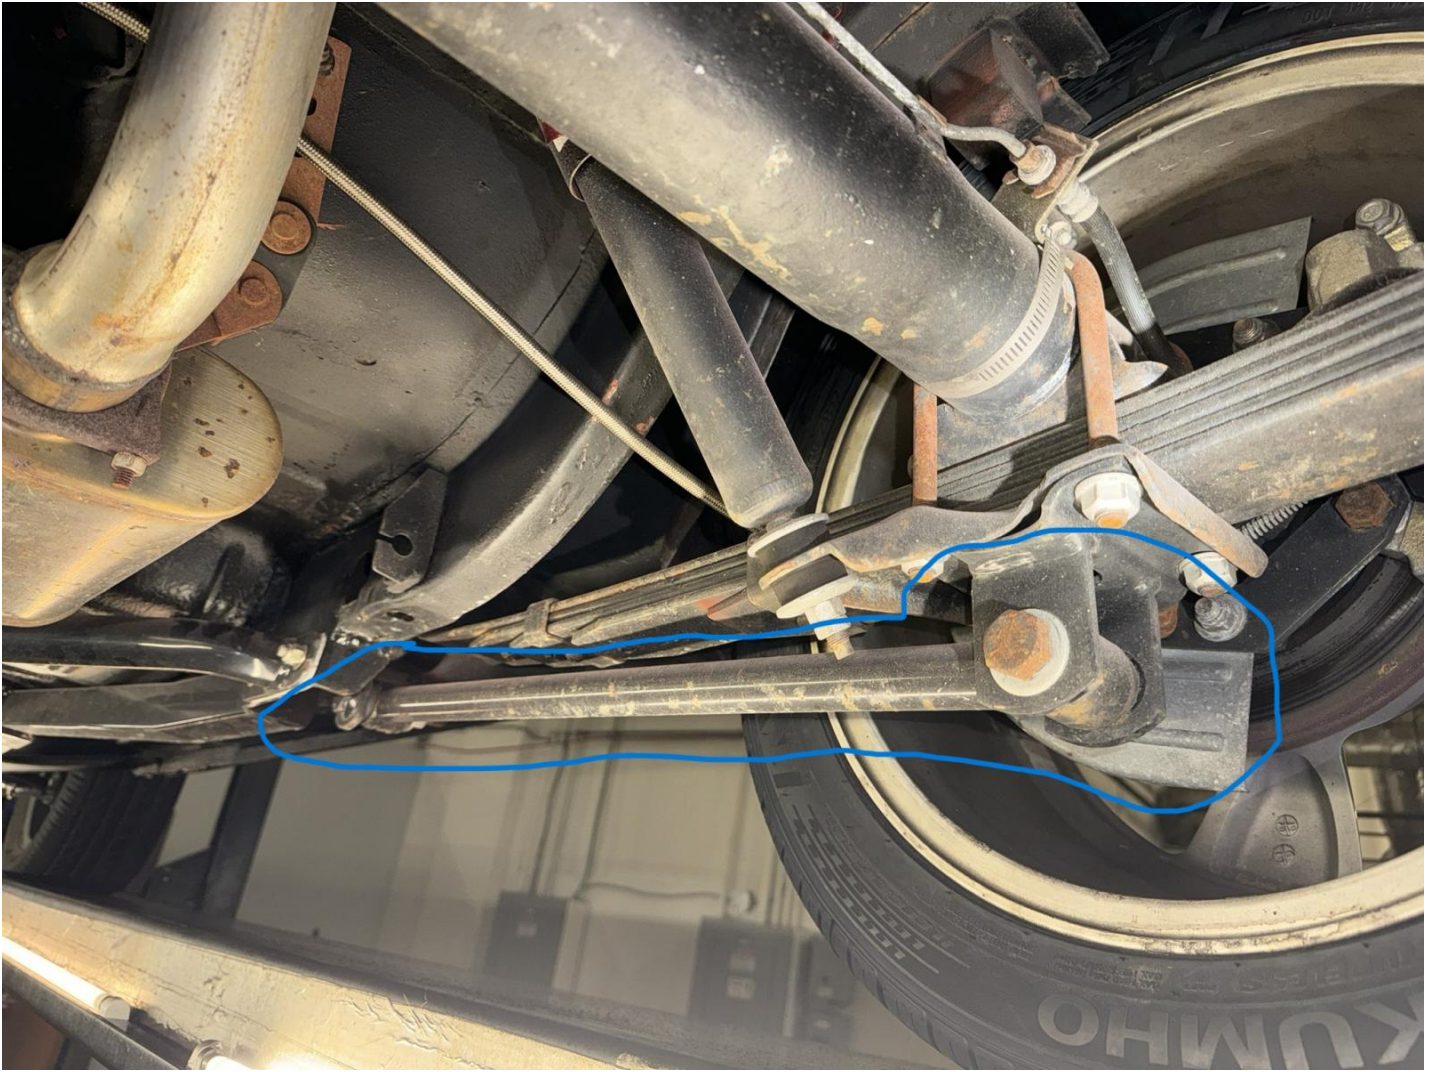
Joints (visual control)	non factory rear control arms, broken pin weld on the left side
-------------------------	---

non factory control arm

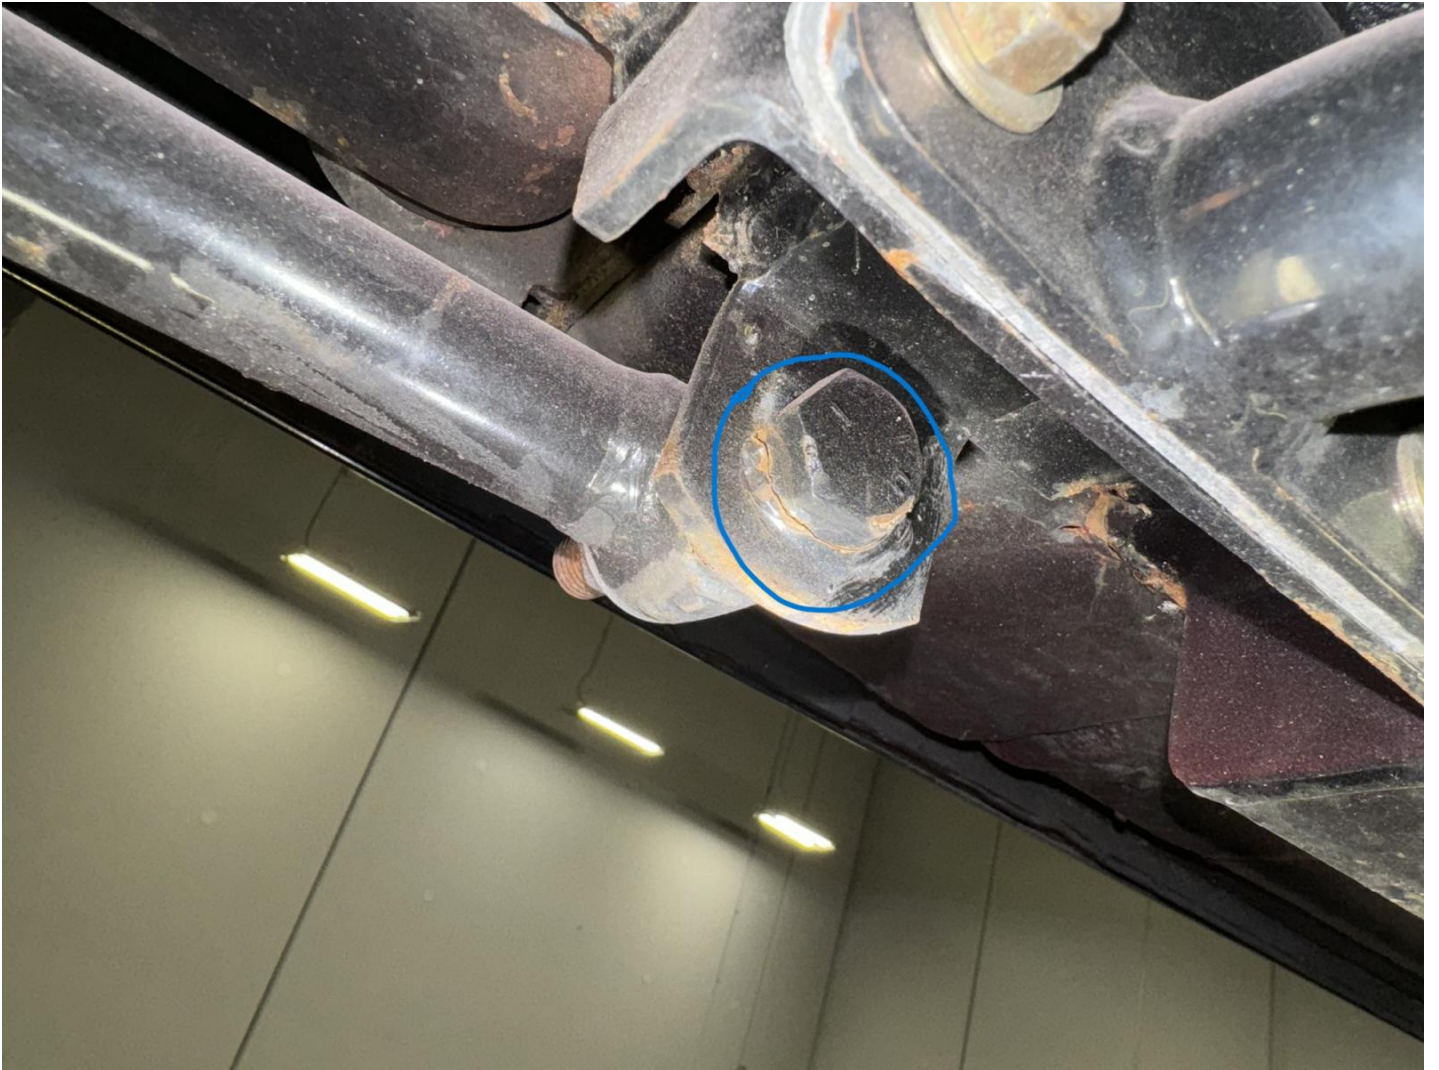
cracked weld

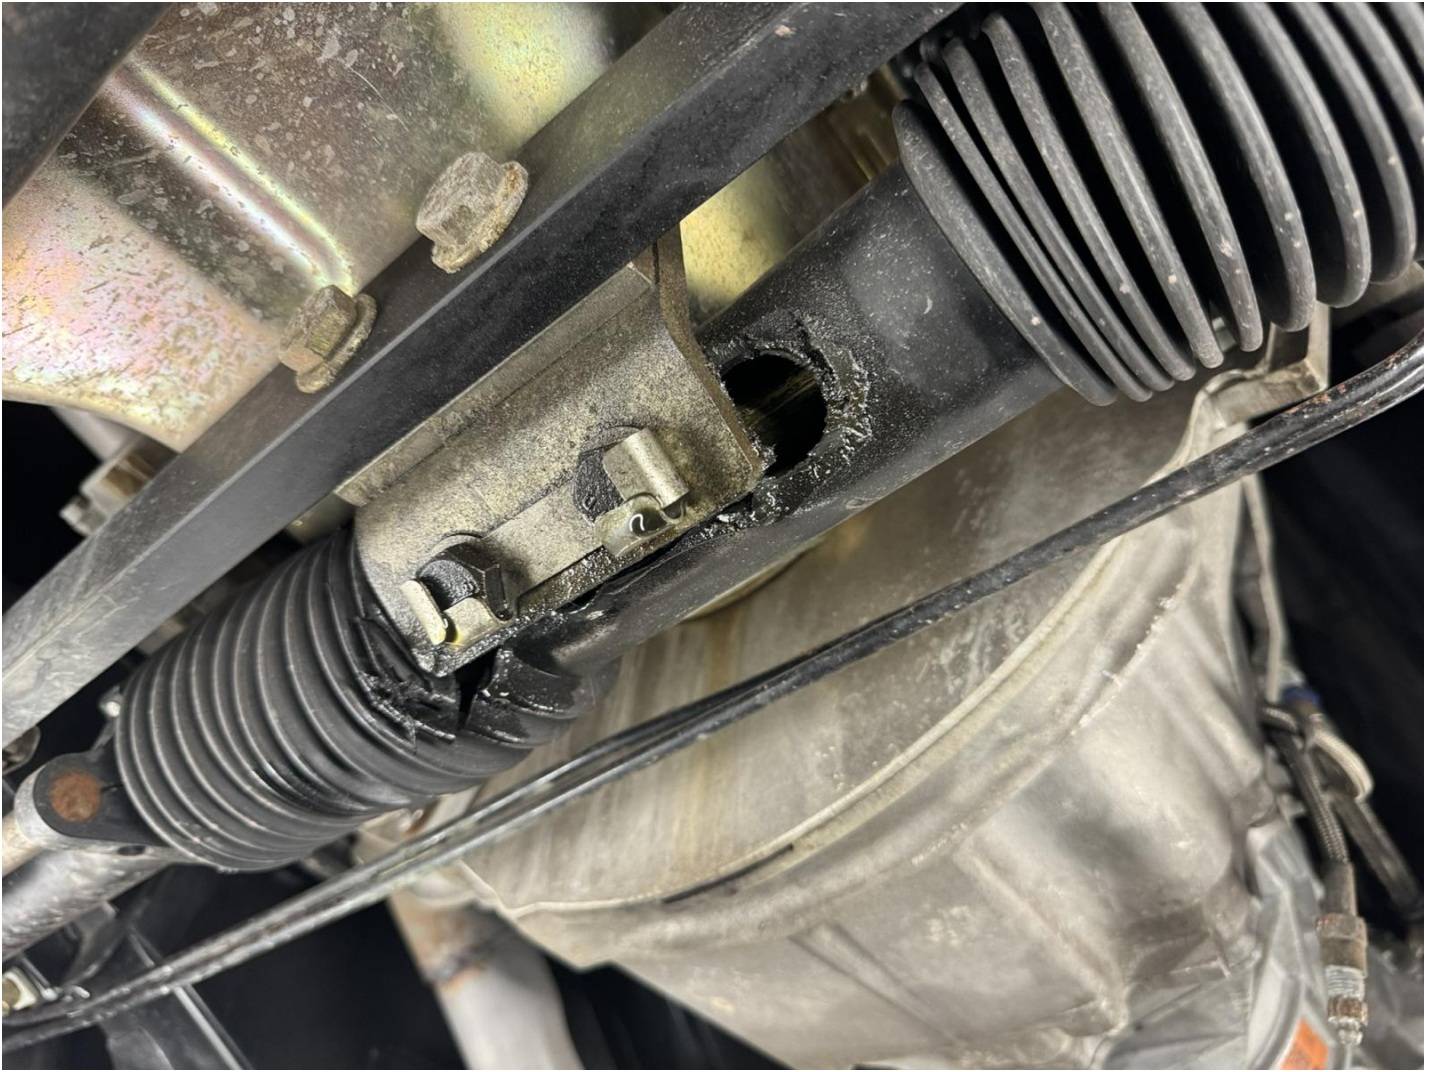
The steering needs attention: the steering rack is leaking, there is small play (backlash) in the steering, and the left rack boot is torn. A leaking rack with a torn boot will let dirt in and can lead to faster wear and eventual rack replacement, so plan to address this. Most concerning on the suspension is the non-factory rear control arm setup with a broken pin weld on the left side — a failed weld on a suspension mounting point is a safety risk and should be inspected and repaired by a competent shop before driving the car hard. Minor items include a non-working left reverse light, missing grille bolts, a central box that won't lock, and missing headliner trim. Also note the odometer was replaced, so the displayed mileage cannot be verified.

Fluid leaks steering rack leak

steering rack leak

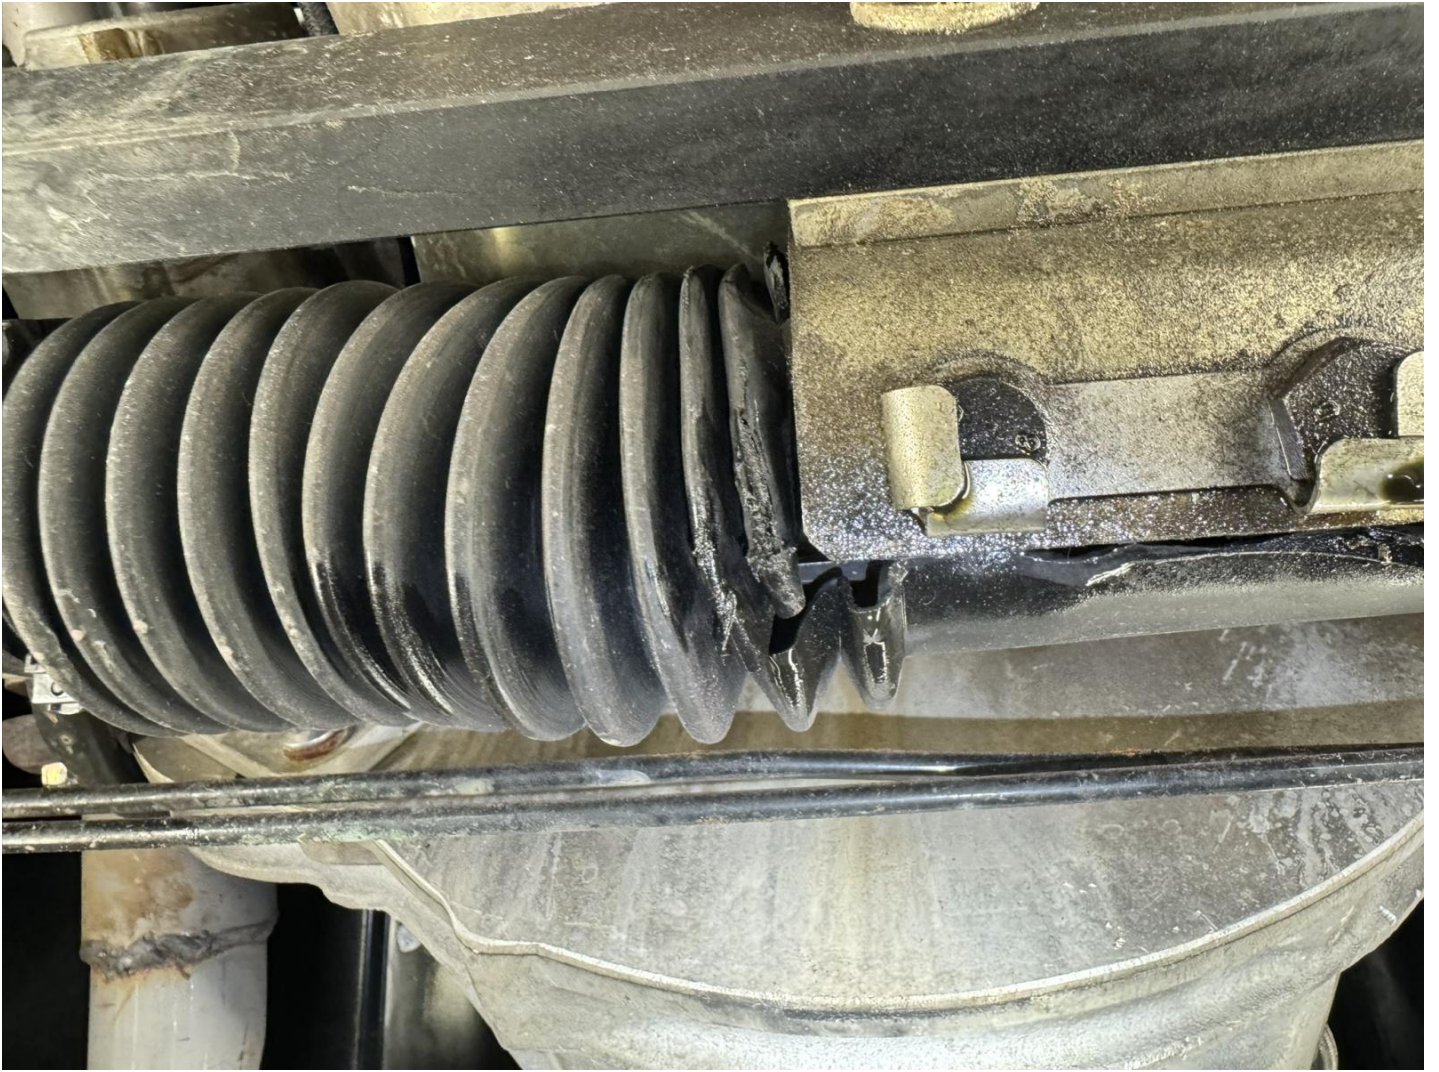
Boots	left steering rack boot is torn
-------	---------------------------------

torn steering rack boot

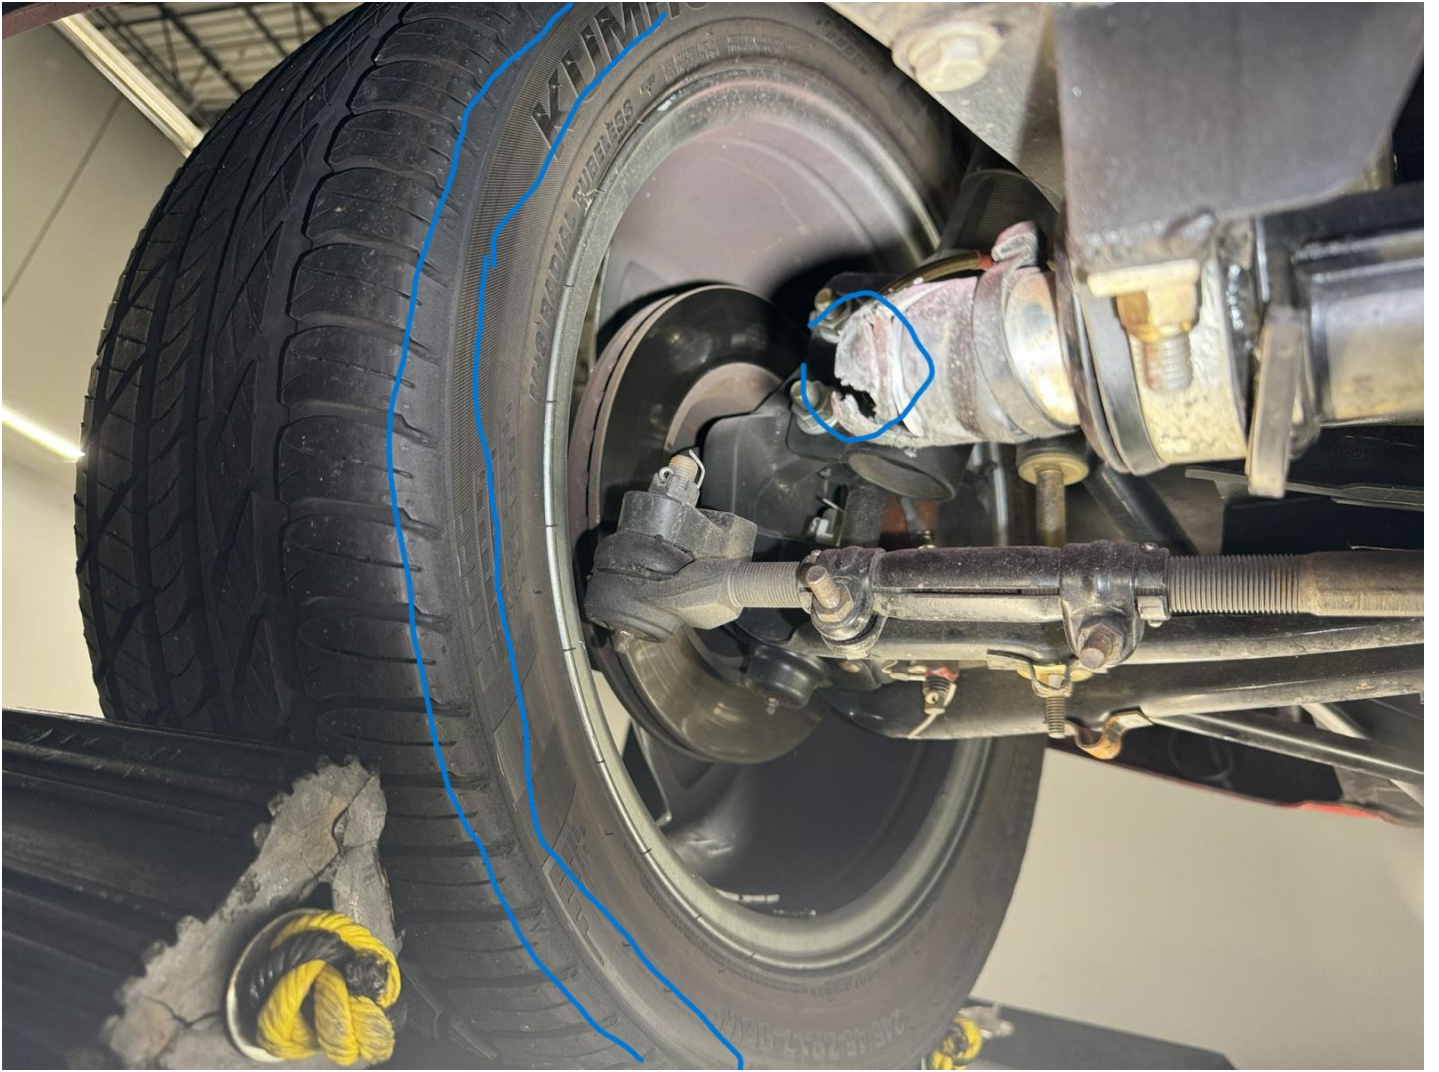
left tire touches the steering rack

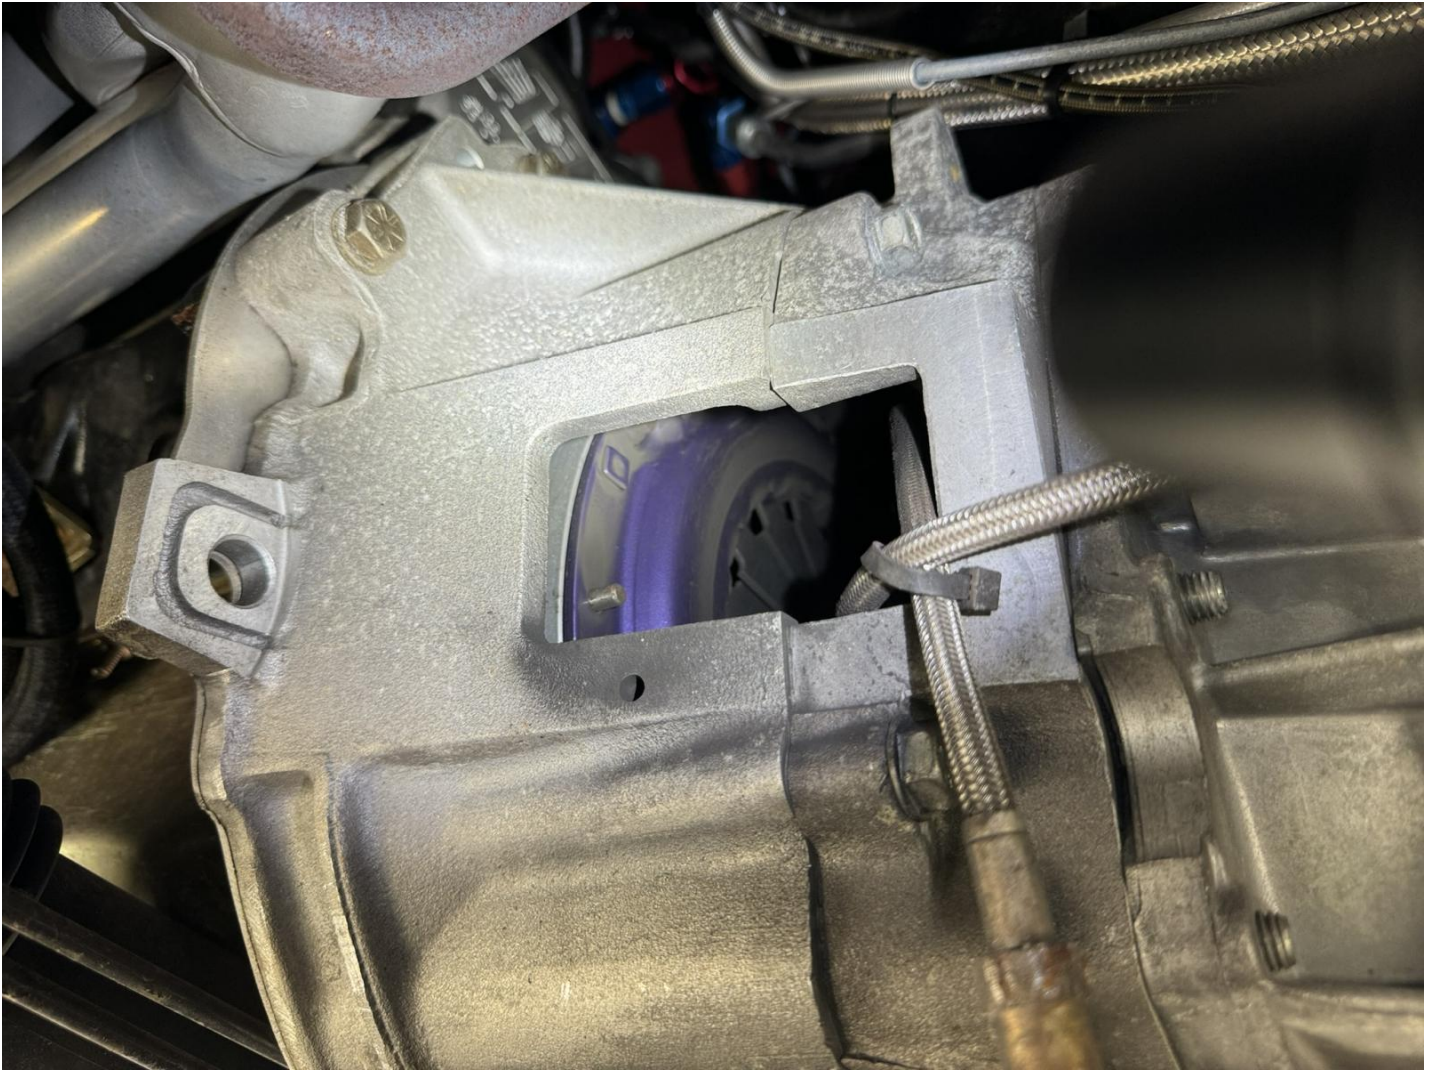
missing cover

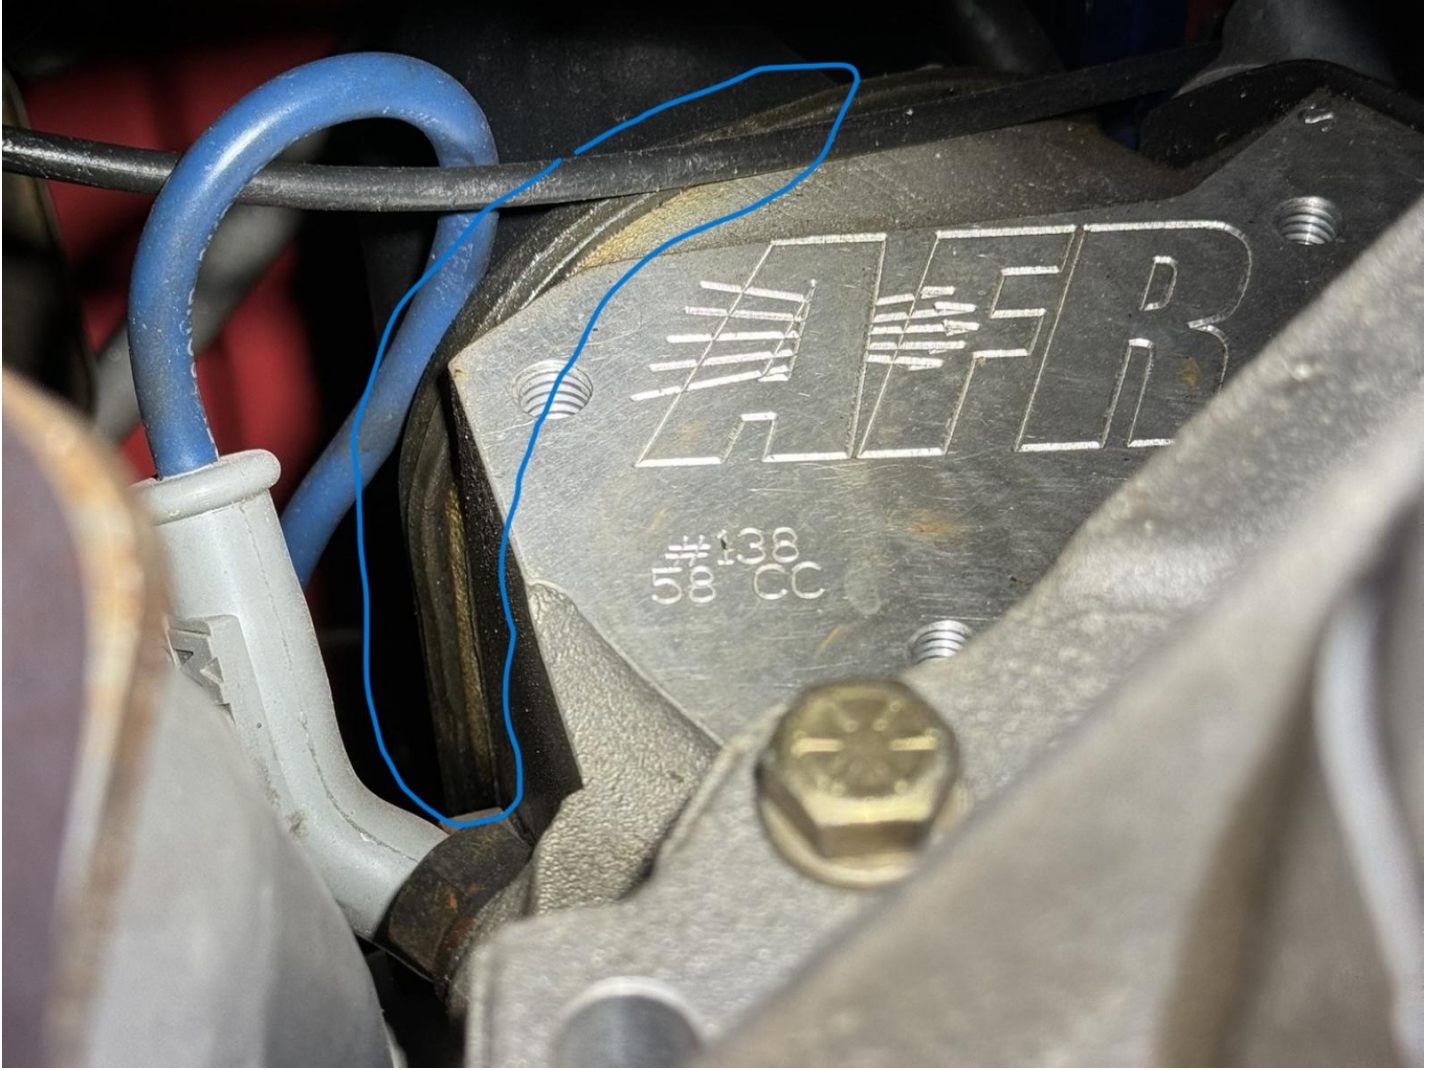
Mechanically the engine runs well with clean oil and no abnormal noise, but there is an oil leak from the valve cover gaskets. This is a common, relatively minor leak, but left unattended oil can drip and create a mess or fire risk near hot components, so it should be resealed. There is also oil residue on the transmission housing and an active leak from the rear differential — these should be monitored and resealed to avoid running components low on fluid over time. The clutch feels too stiff, which can point to worn linkage or hydraulic/cable wear and should be checked for comfort and reliability.

valve cover oil leak

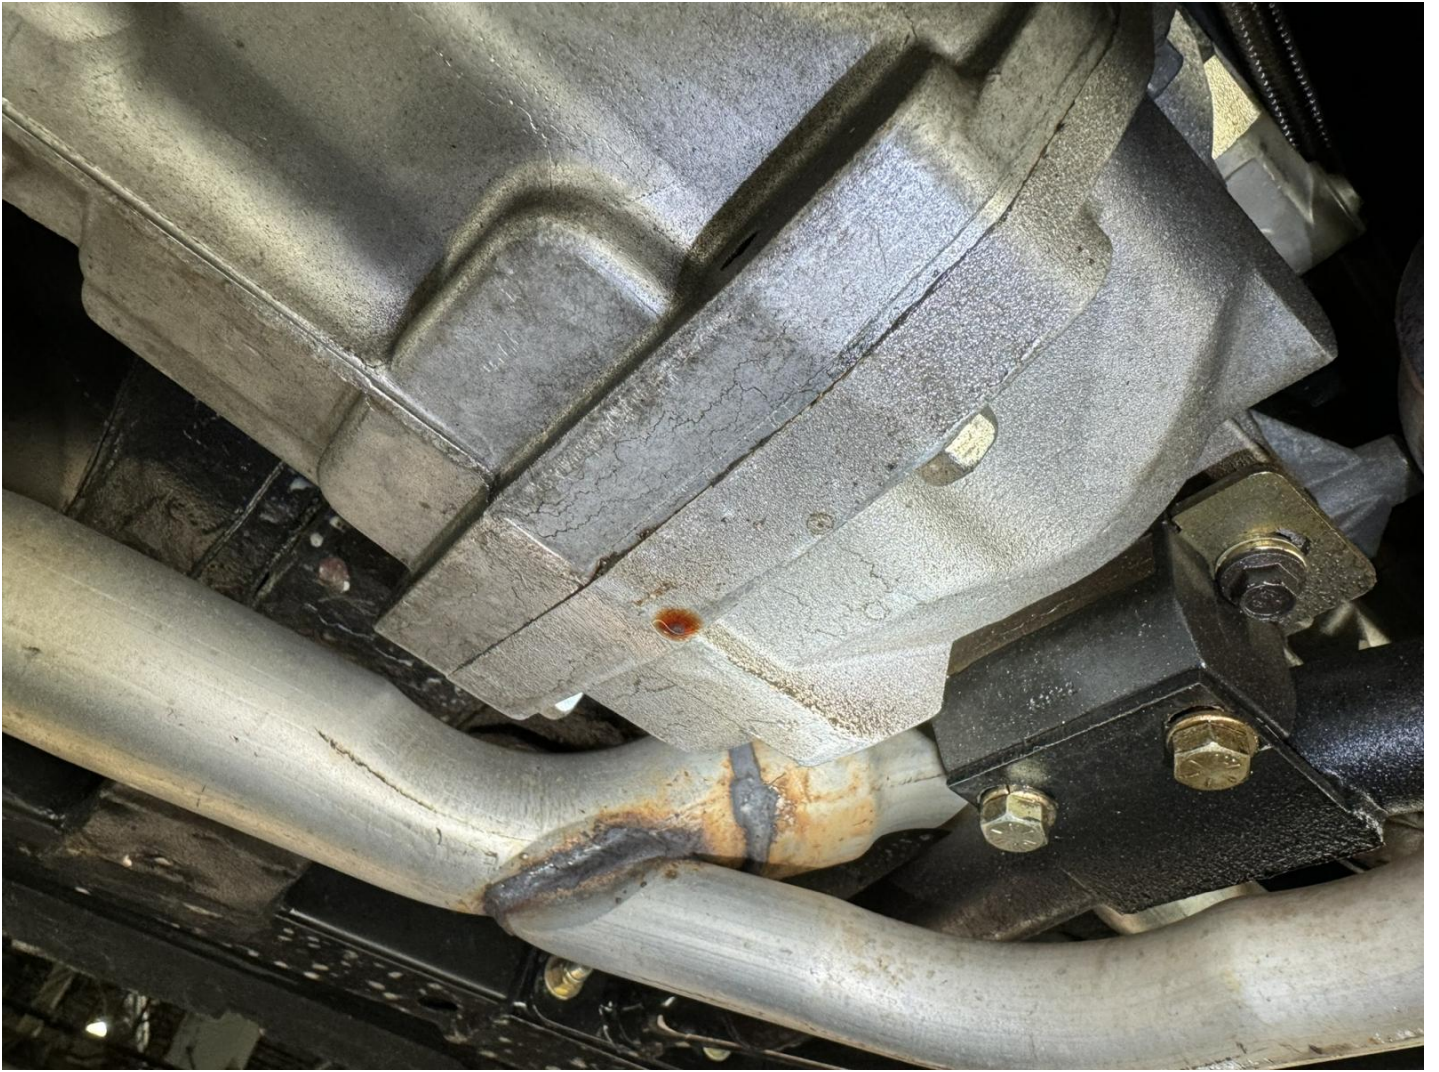
Abnormal Noise	no
Synchronizers	ok
Clutch	too stiff
Shifting force	normal
Oil leaks	oil residue on the transmission housing
Sings of recent repairing	not found

transmission oil leak

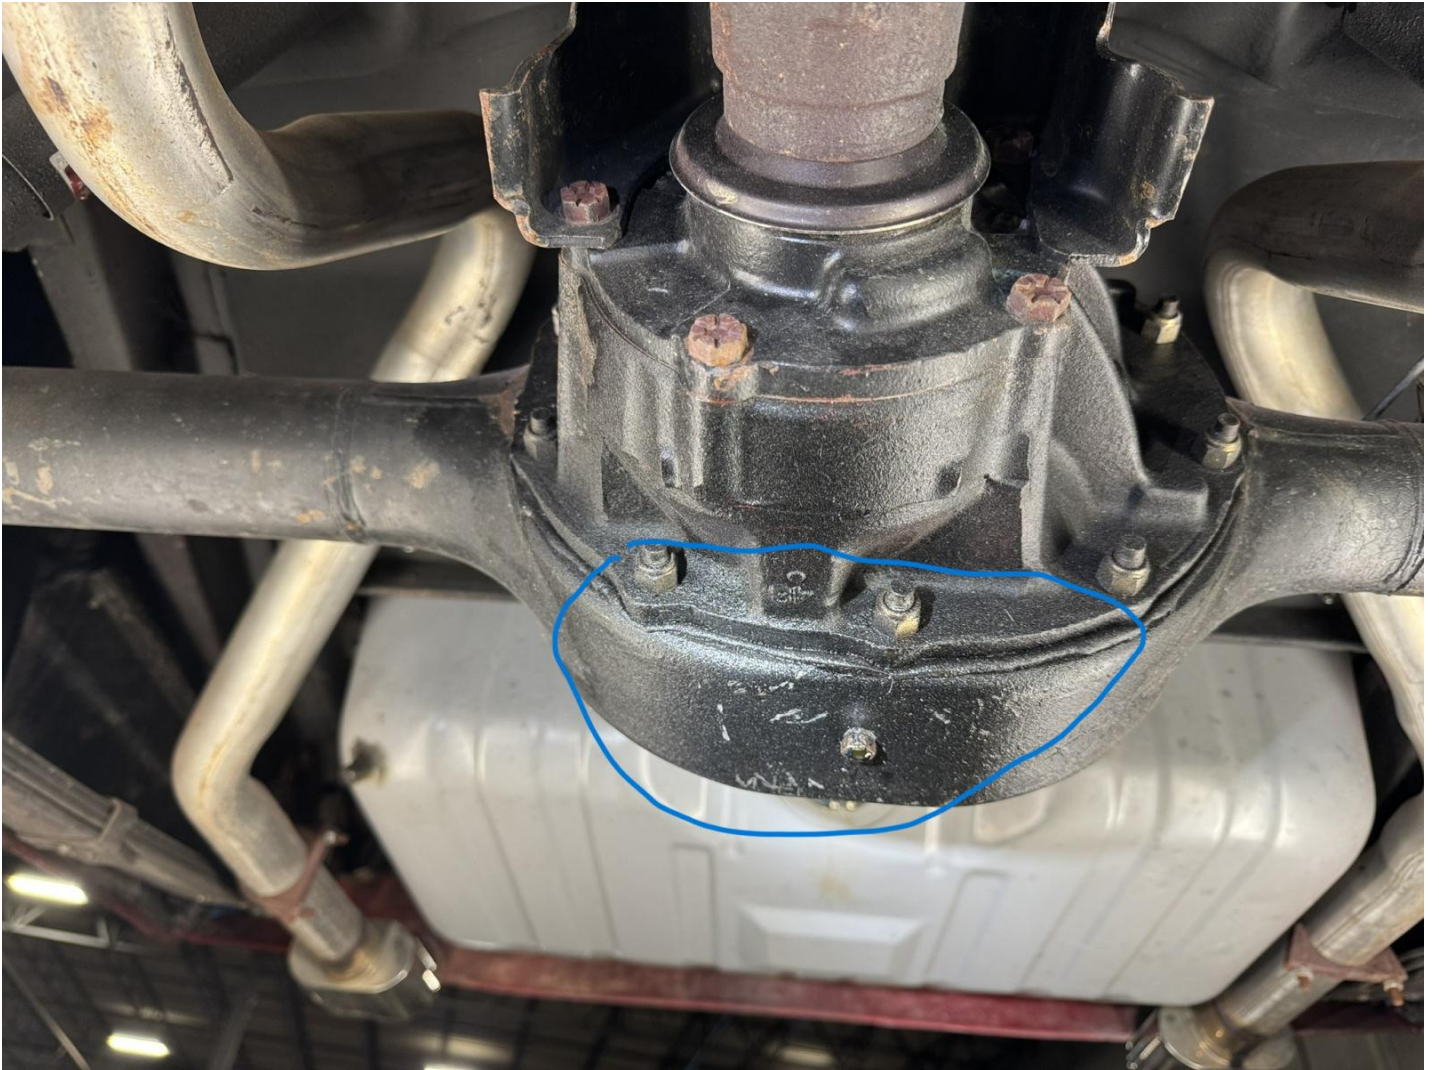
Oil leaks	rear differential oil leak
Abnormal Noise	no
Vibration	no
Clunk	no
Wheel bearings	ok

rear differential oil leak

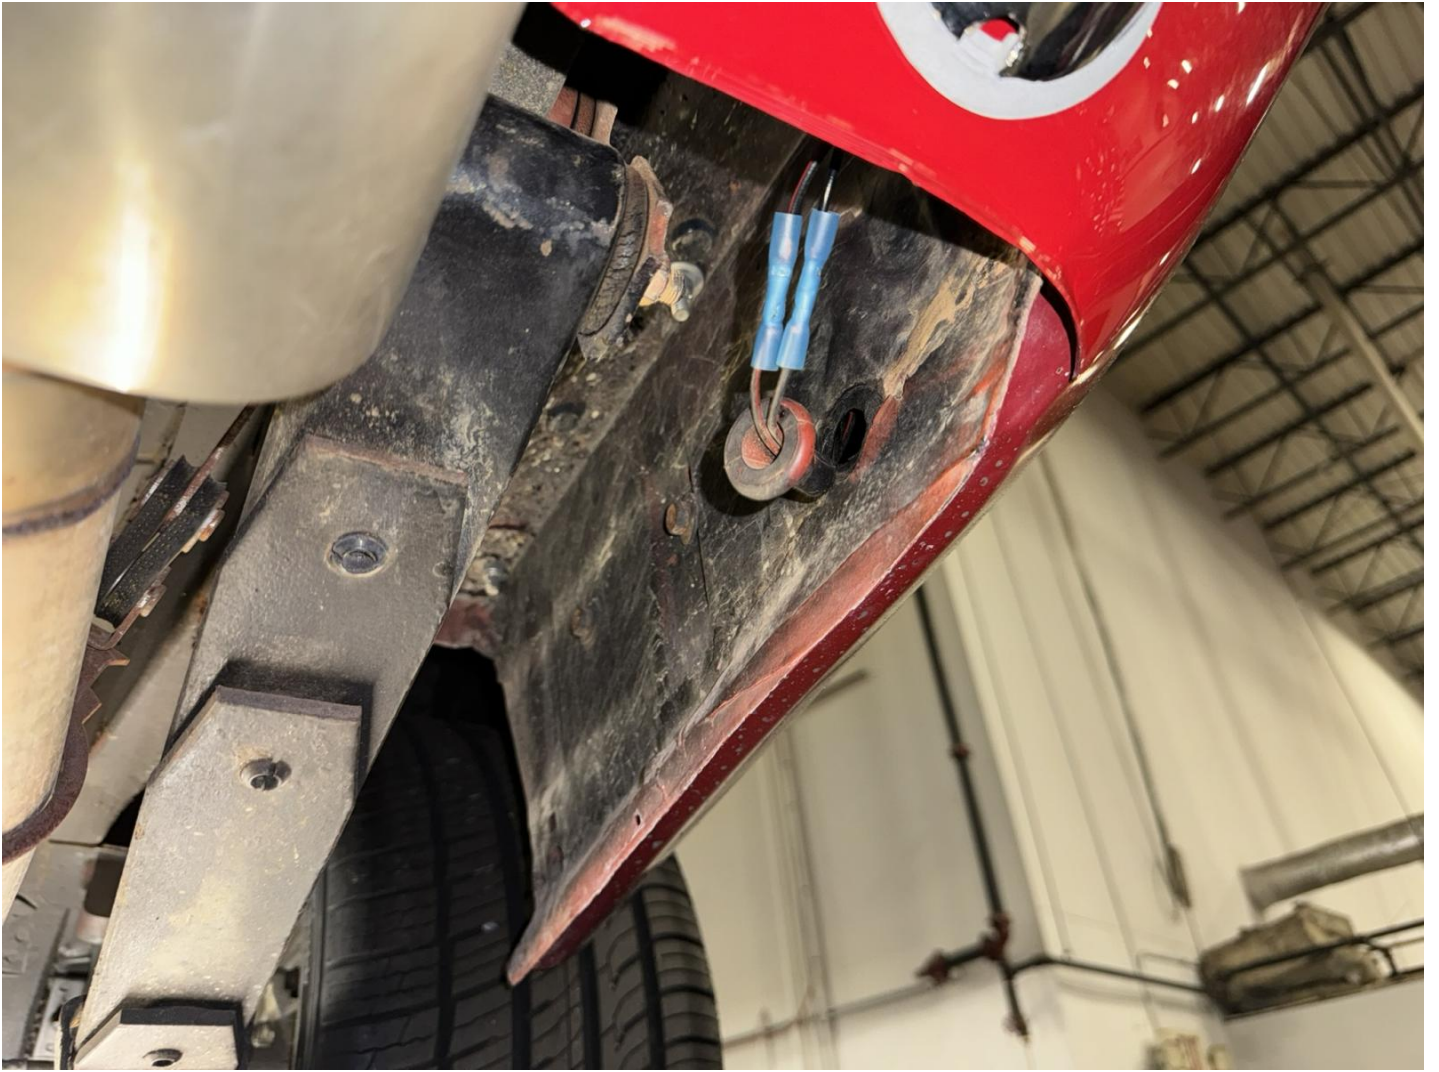
loose wires

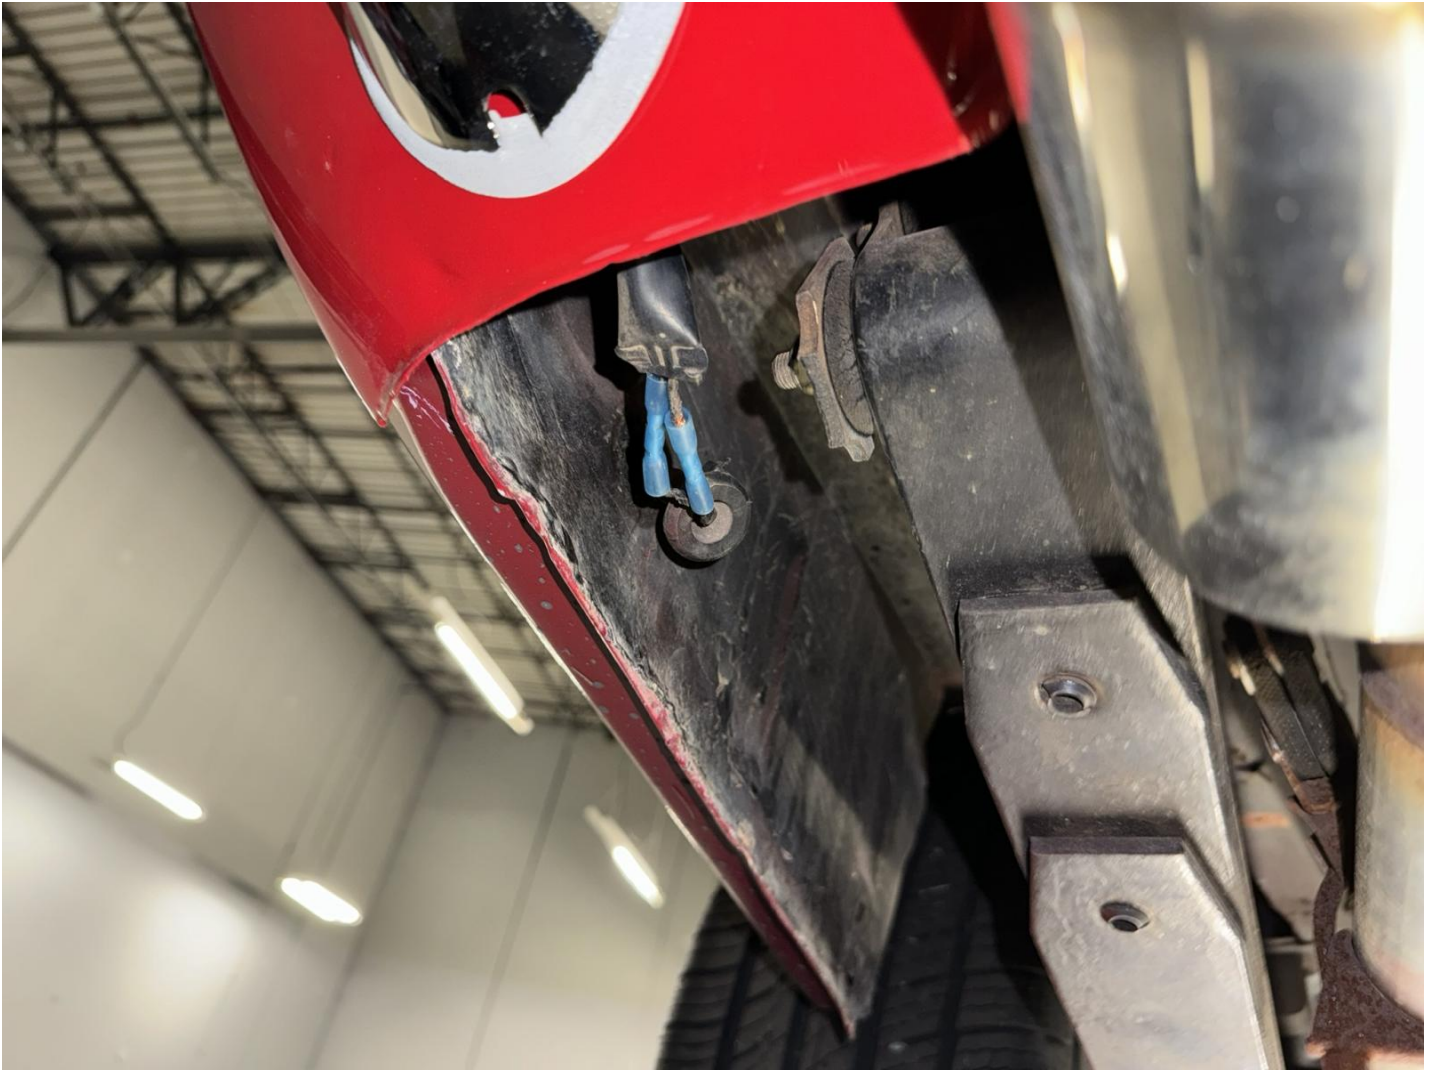
loose wires

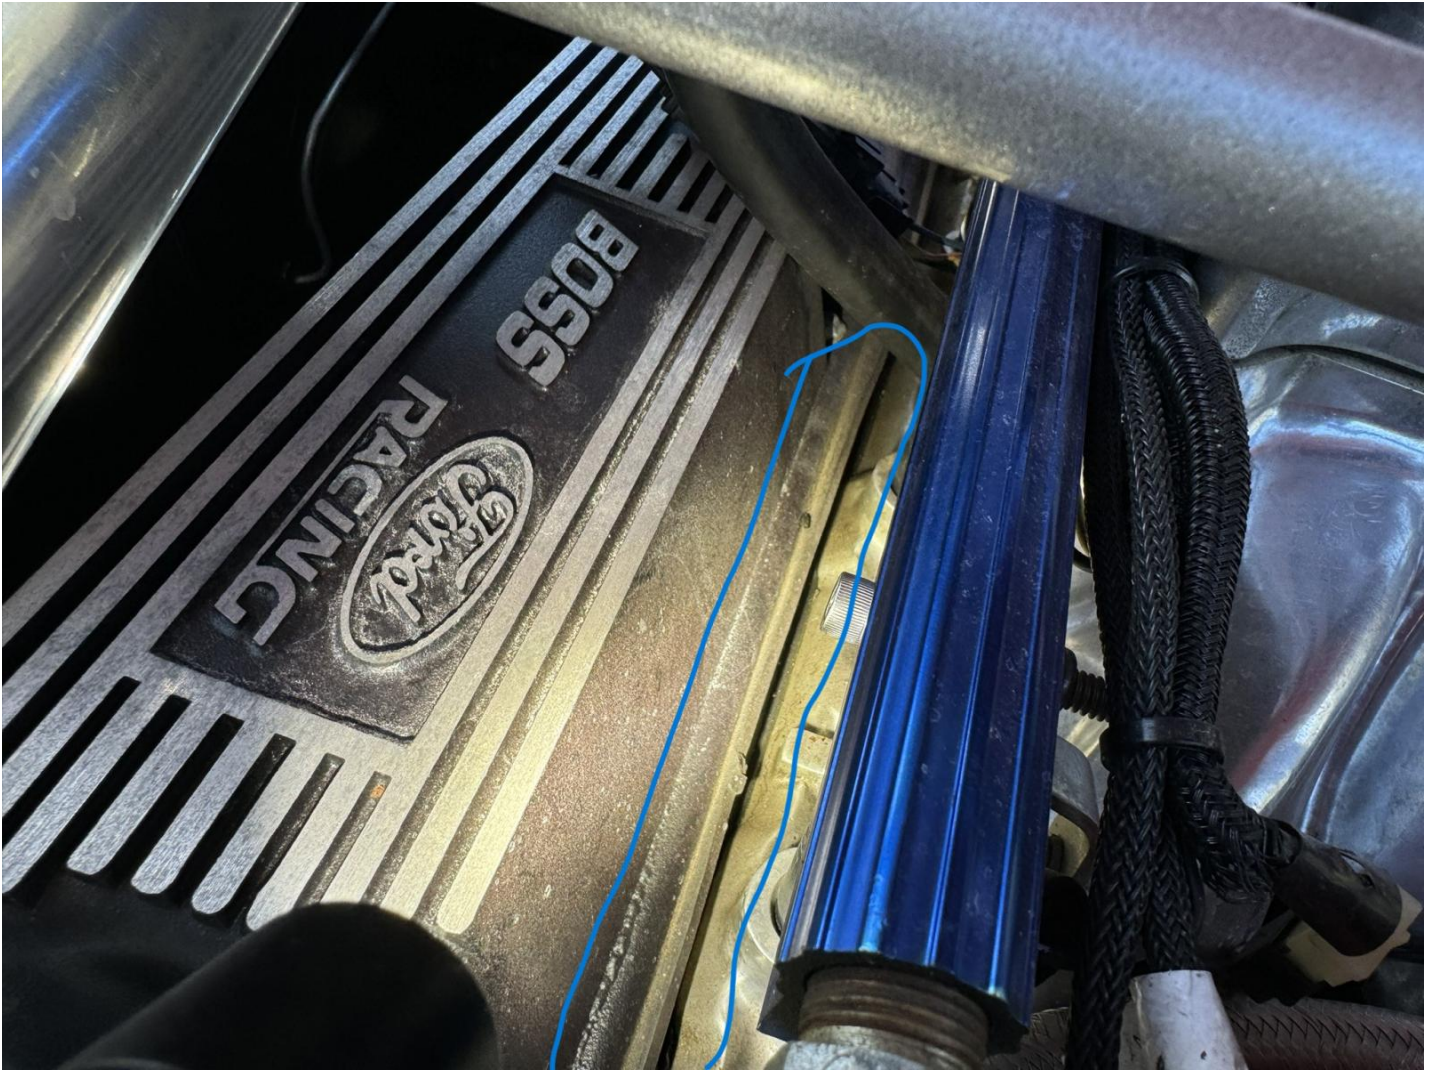
valve cover oil leak

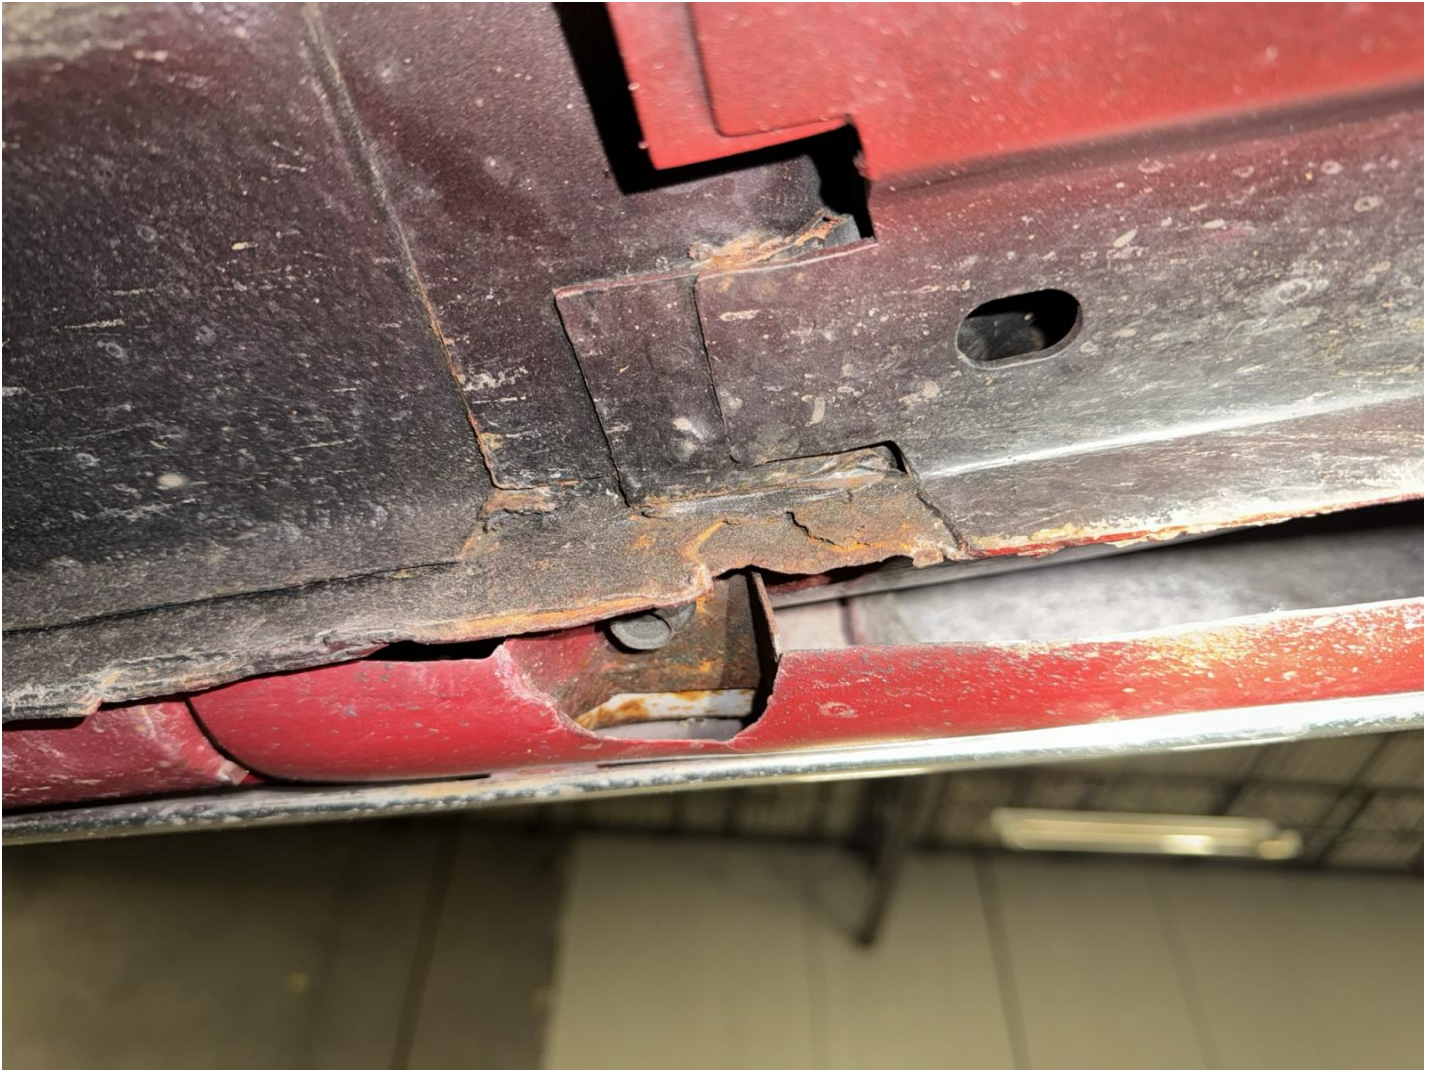
Structural damage The front body structure was replaced (rails, cross-members, aprons). The rear rails were partially repaired due to rust damage (new ones welded over the old ones) and the links between the rear and front rails were added. Quarter panels and rocker panels were replaced.

rocker panel repair

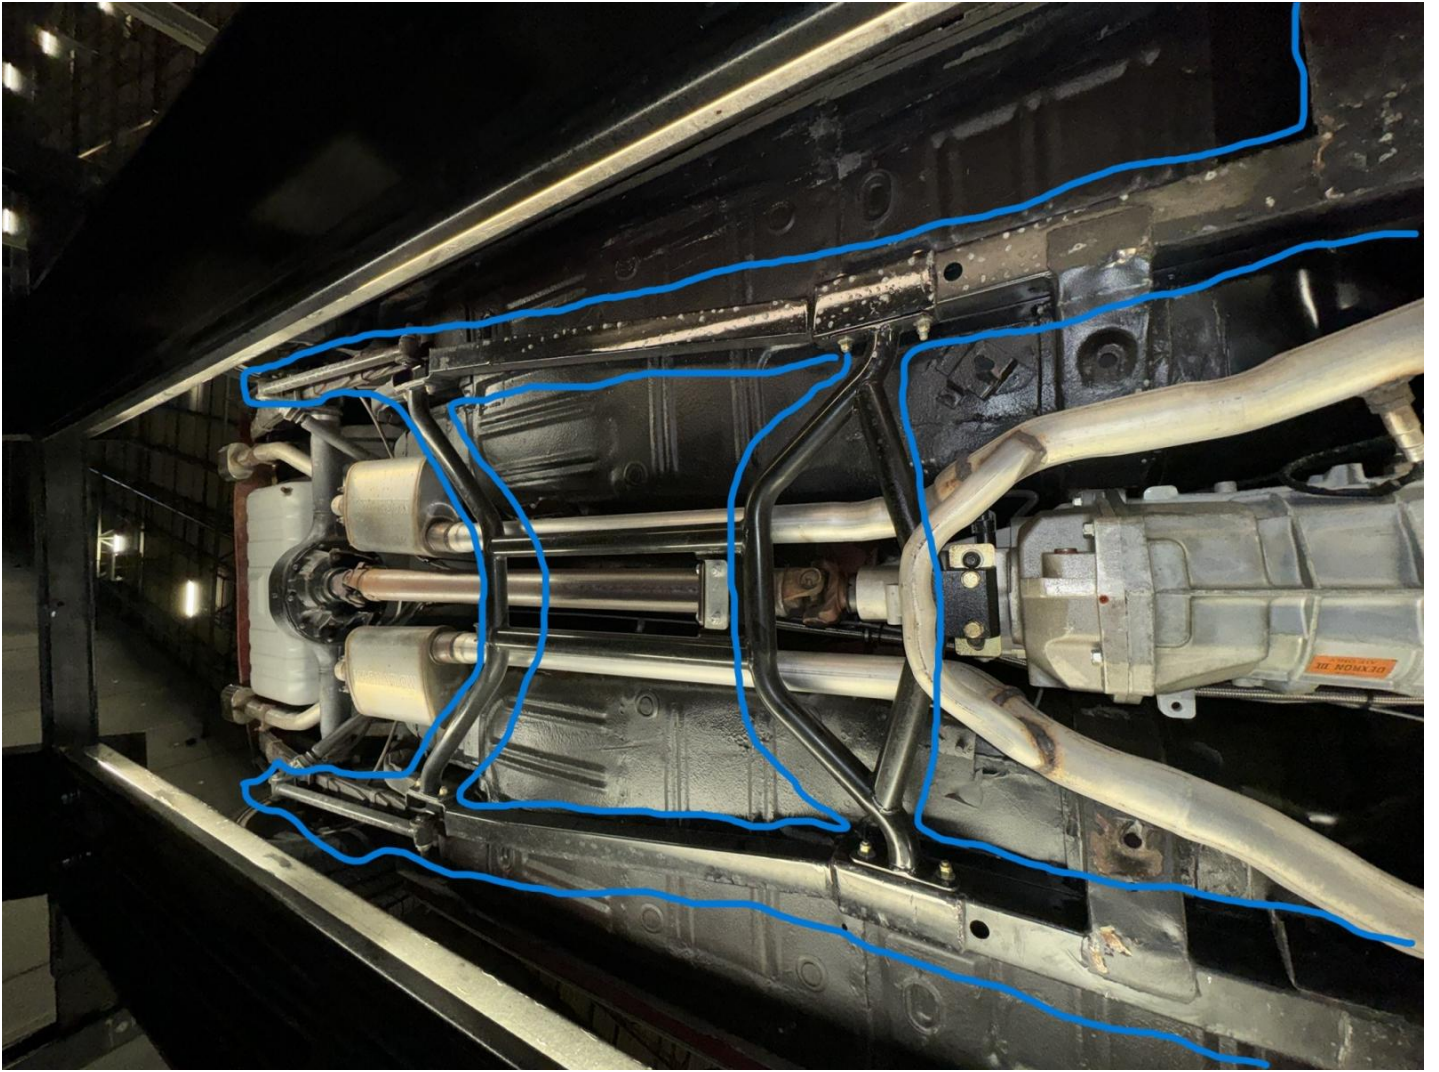
replaced or non-factory parts
