1968 Ford Mustang

Summary

Inspection date: Jan 10 2024
CarAdvisors — Metro Atlanta, GA

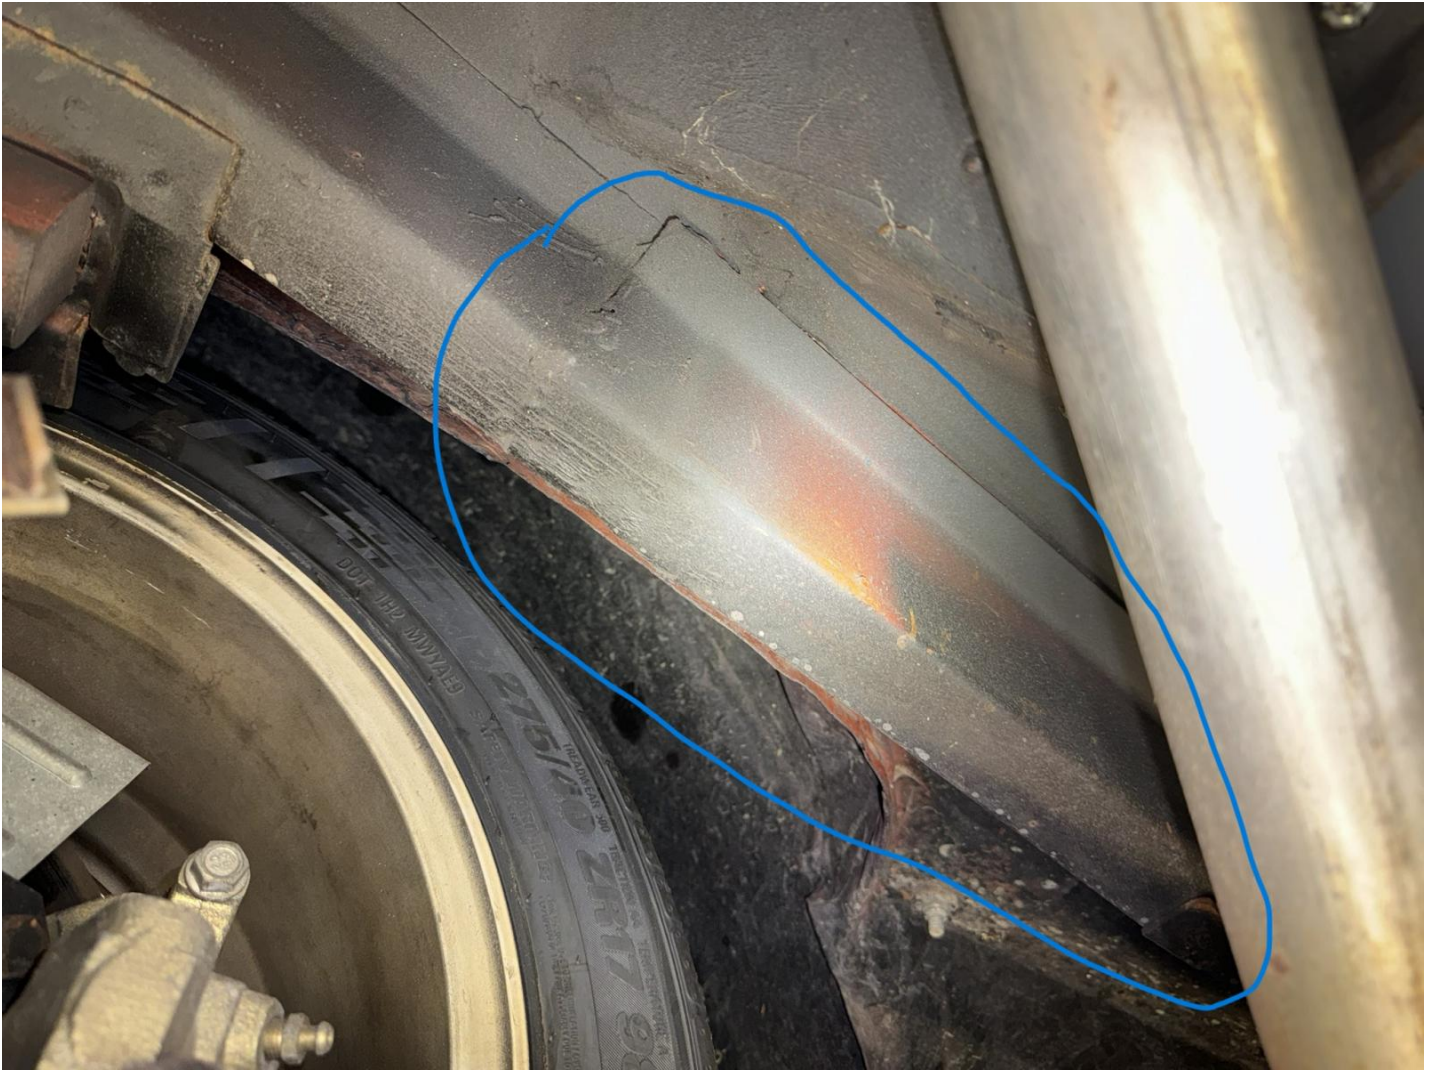
Structural damage The front body structure was replaced (rails, cross-members, aprons). The rear rails were partially repaired due to rust damage (new ones welded over the old ones) and the links between the rear and front rails were added. Quarter panels and rocker panels were replaced.

repaired section of the rear rail

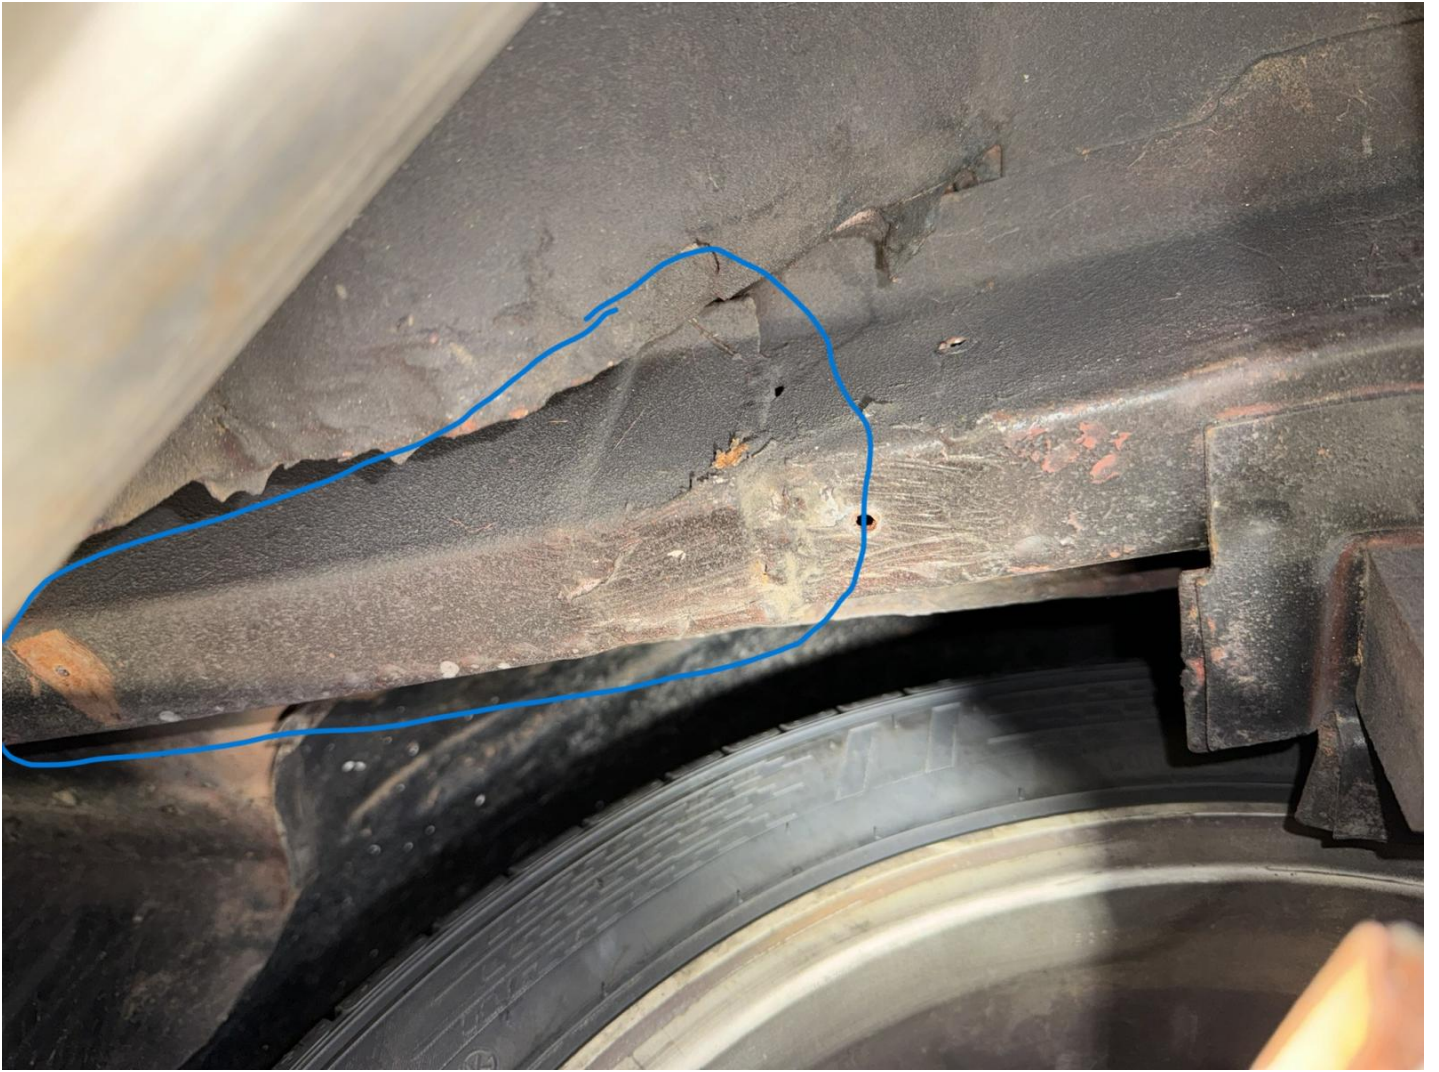
repaired section of the rear rail

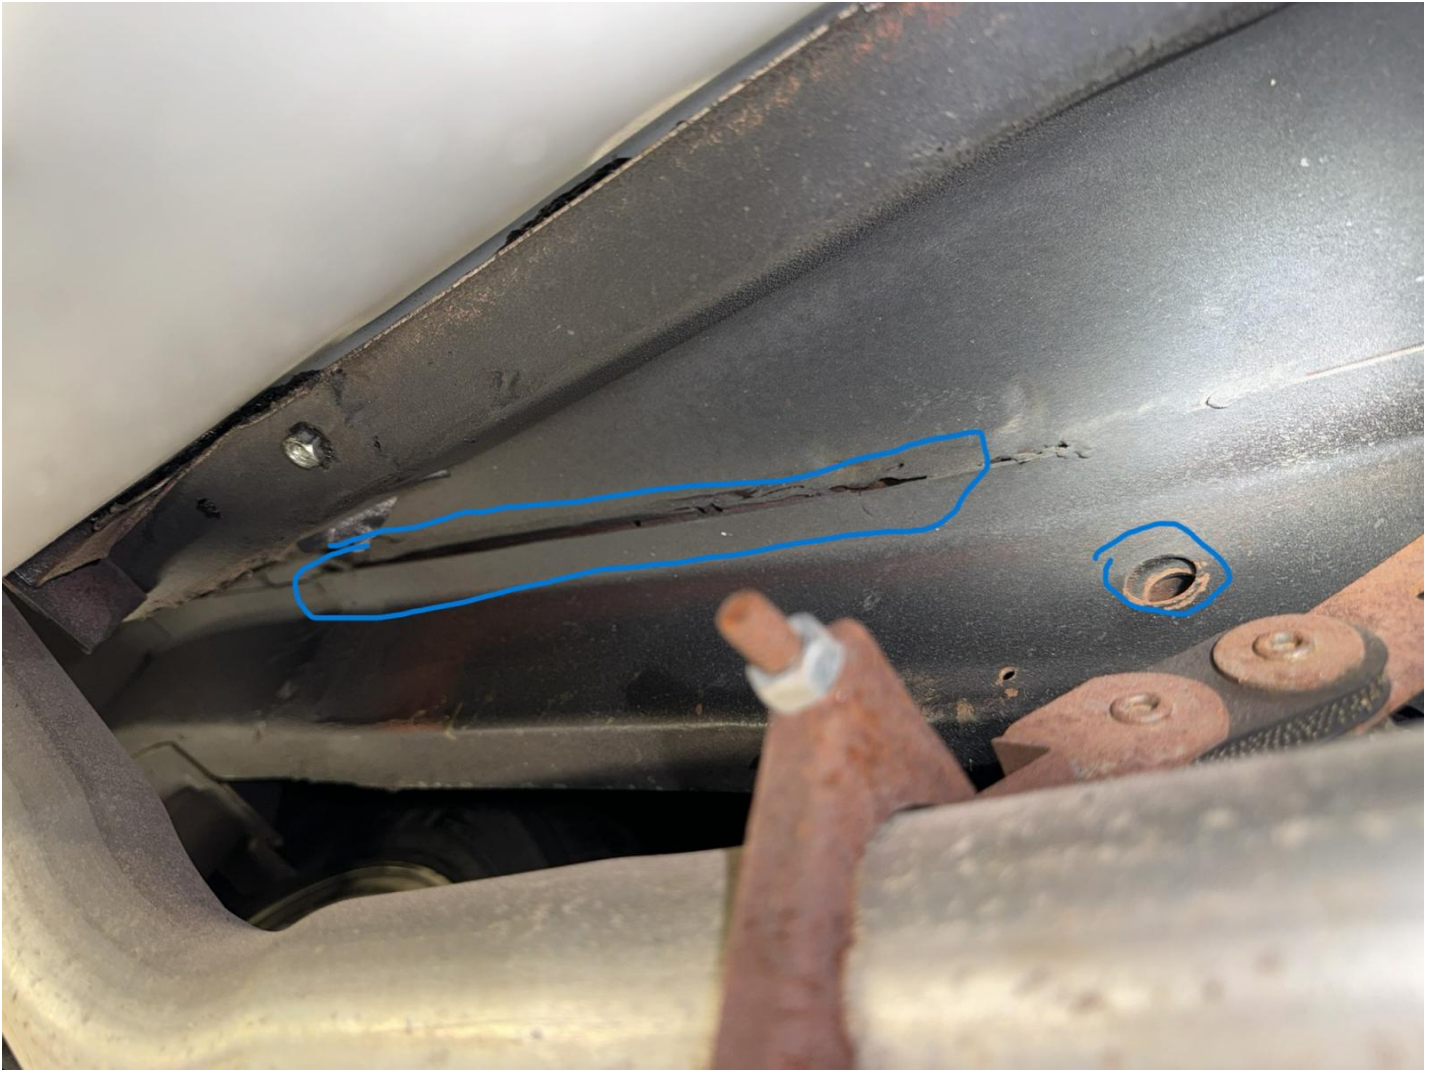
missing welding spots

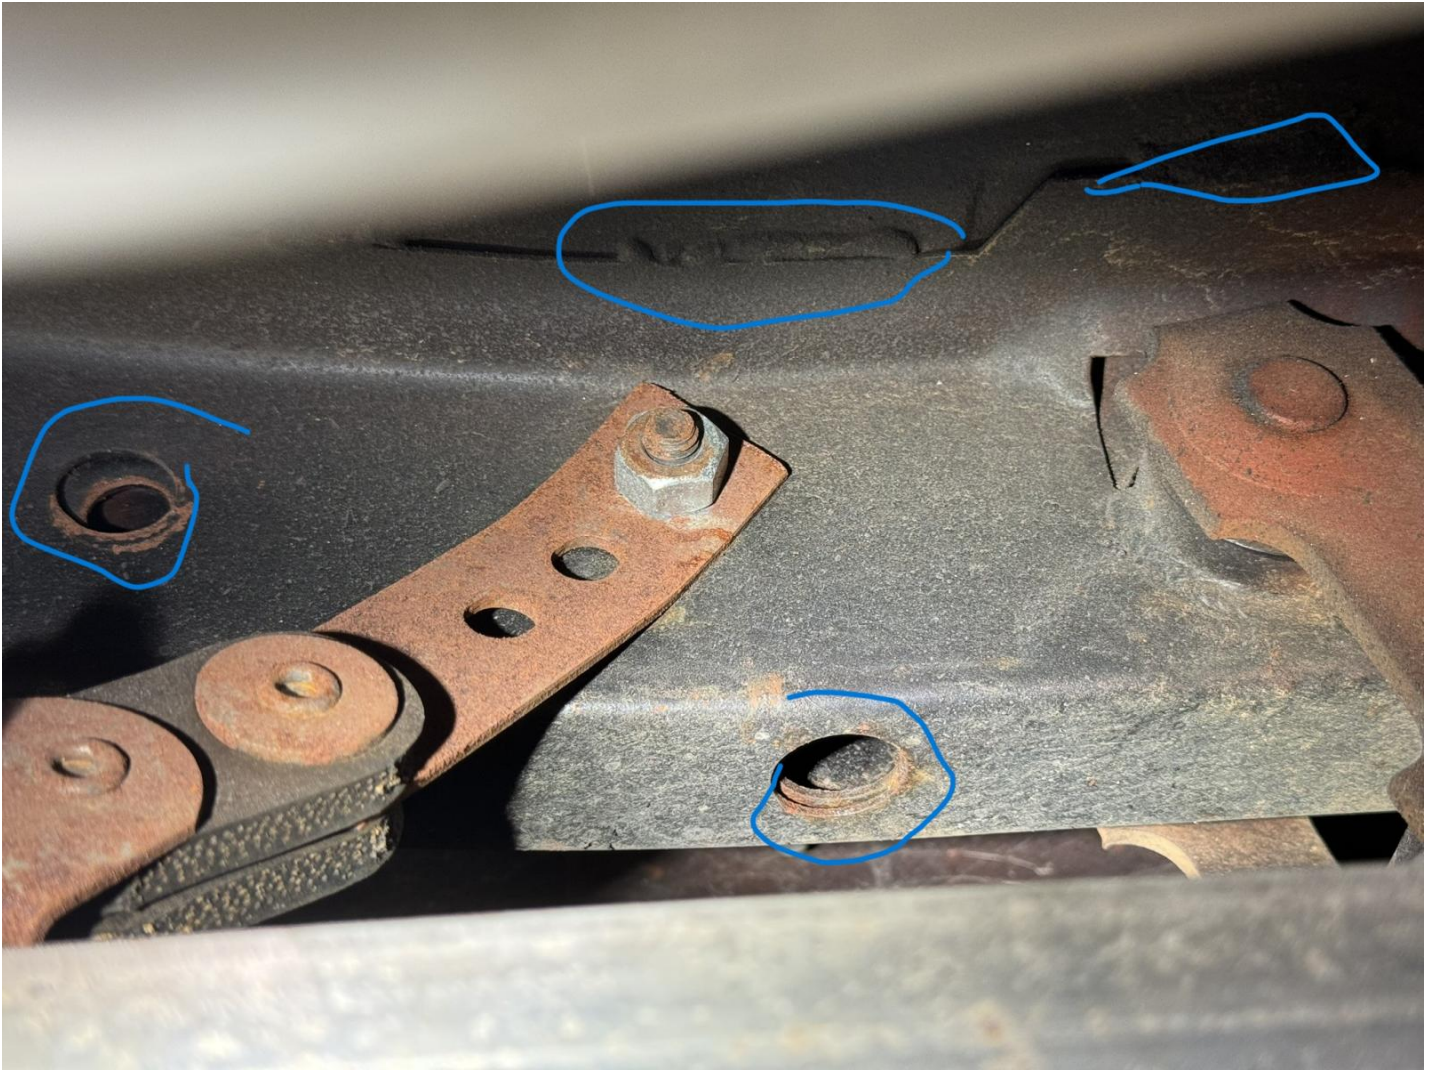
old rail covered with a new one

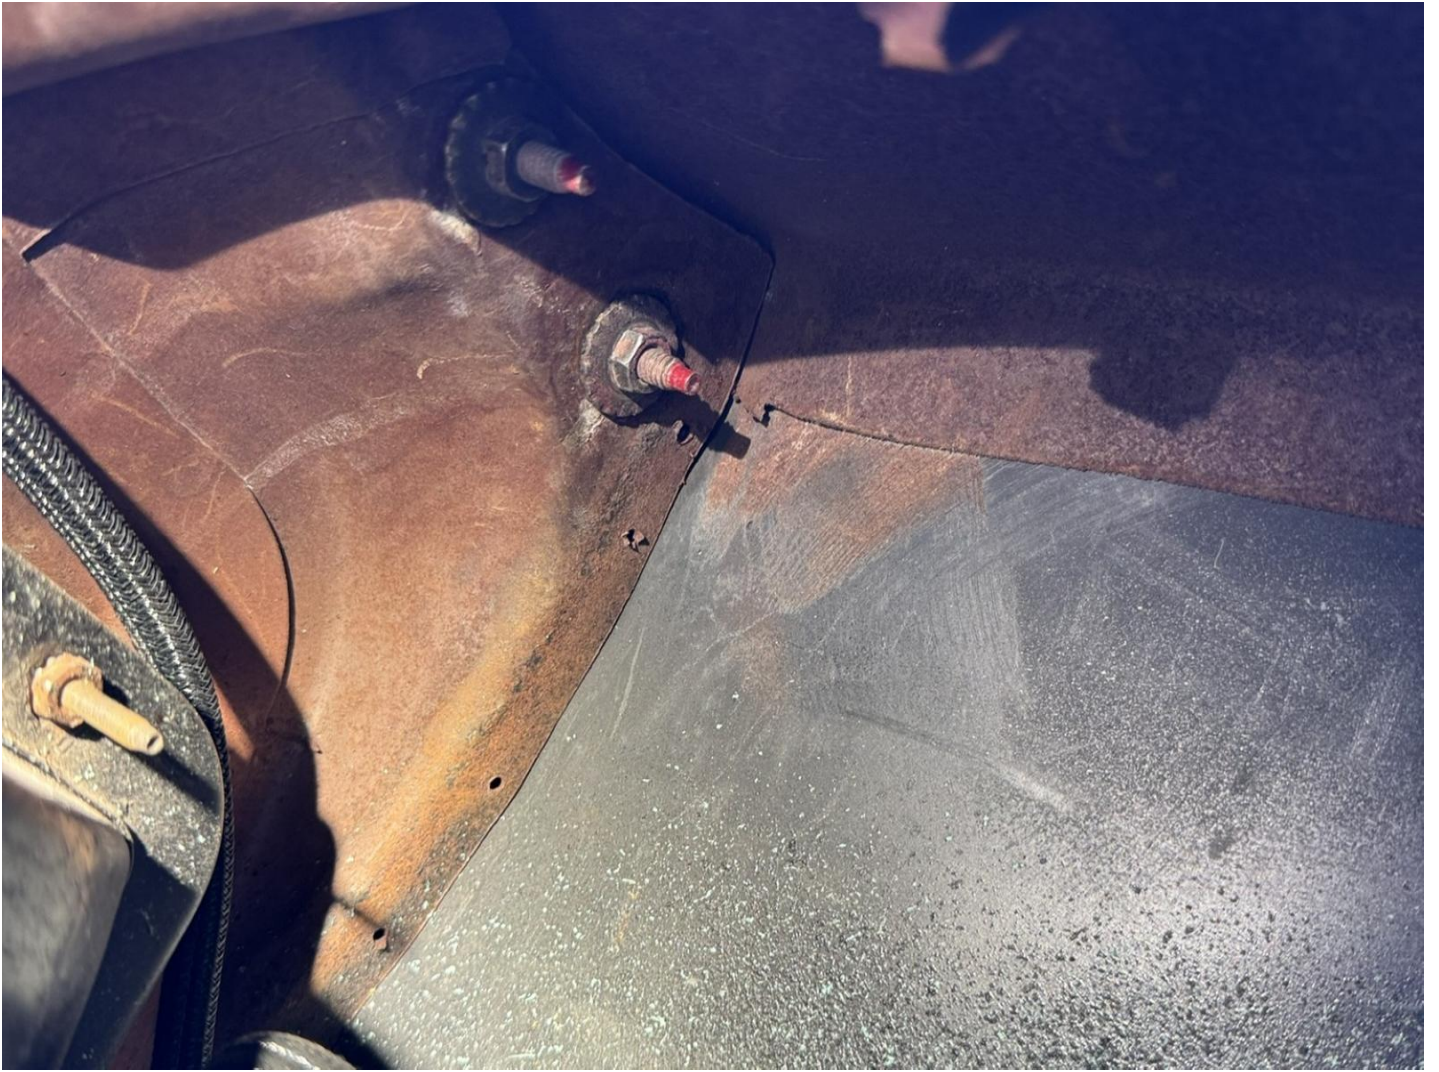
quarter panels were replaced

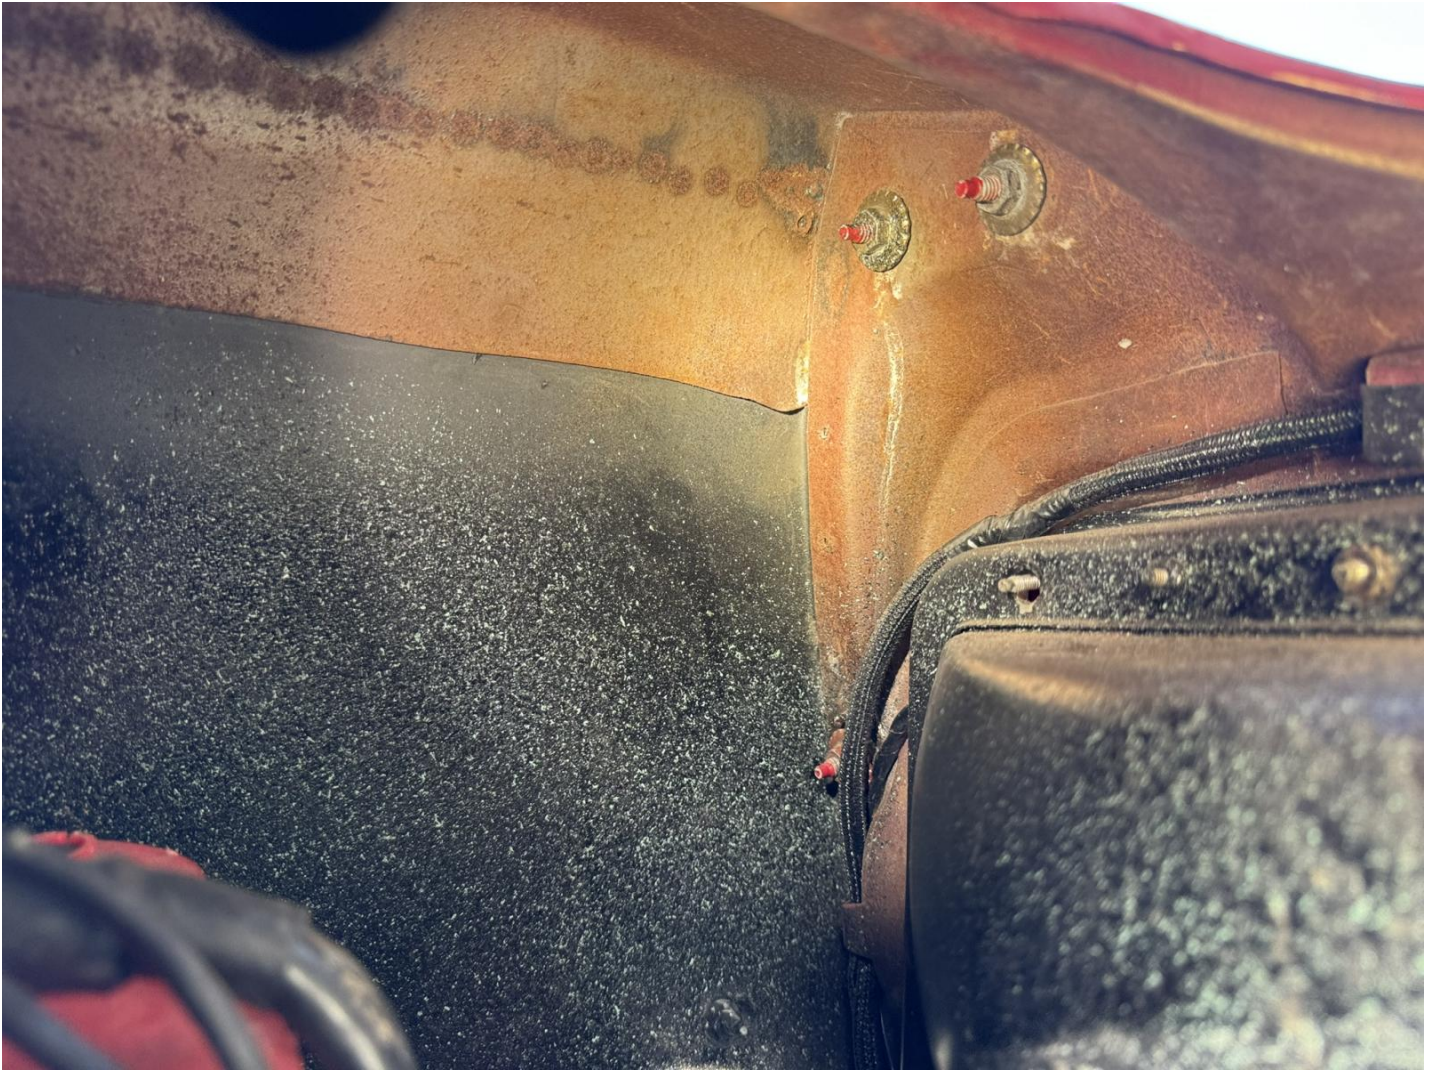
quarter panels were replaced

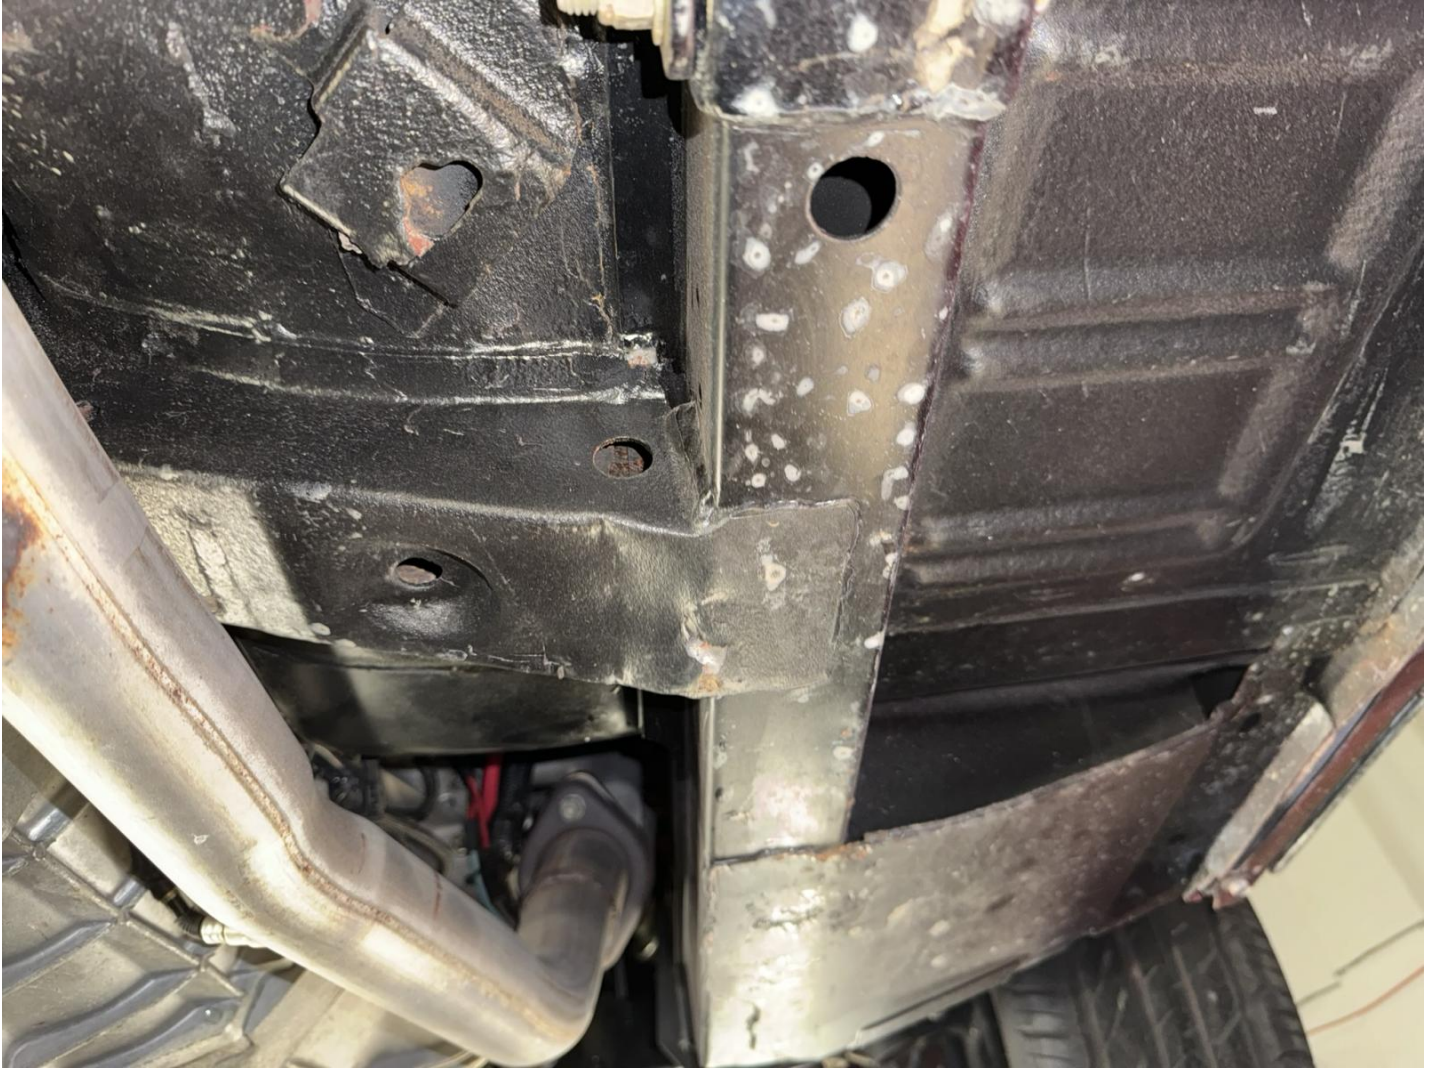
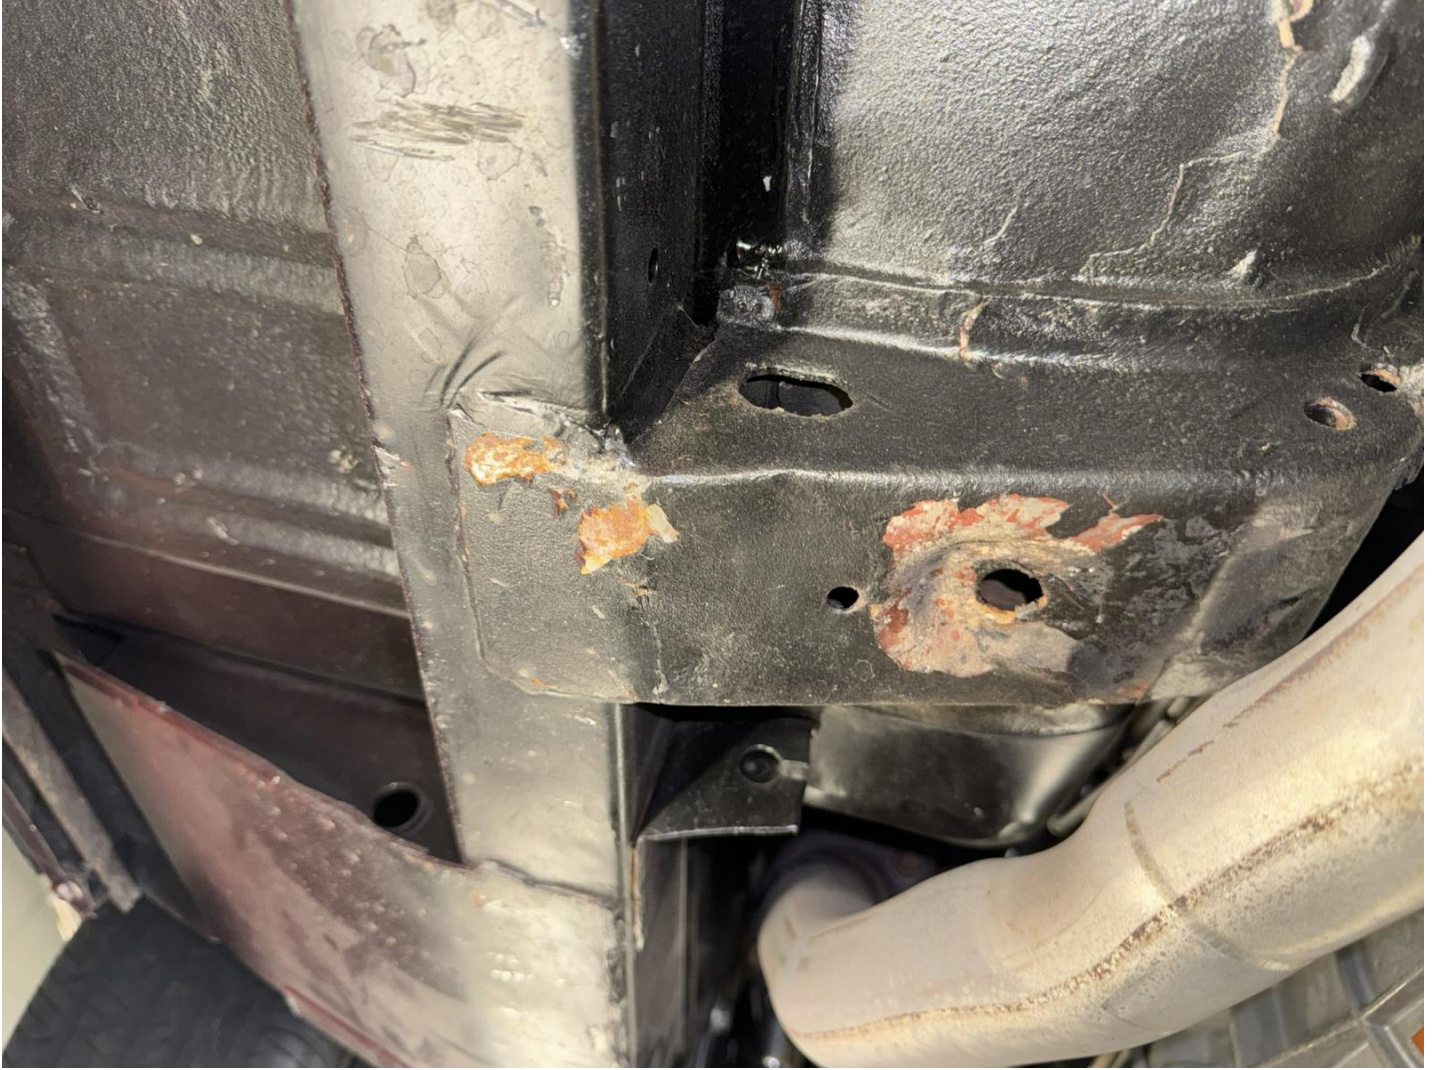
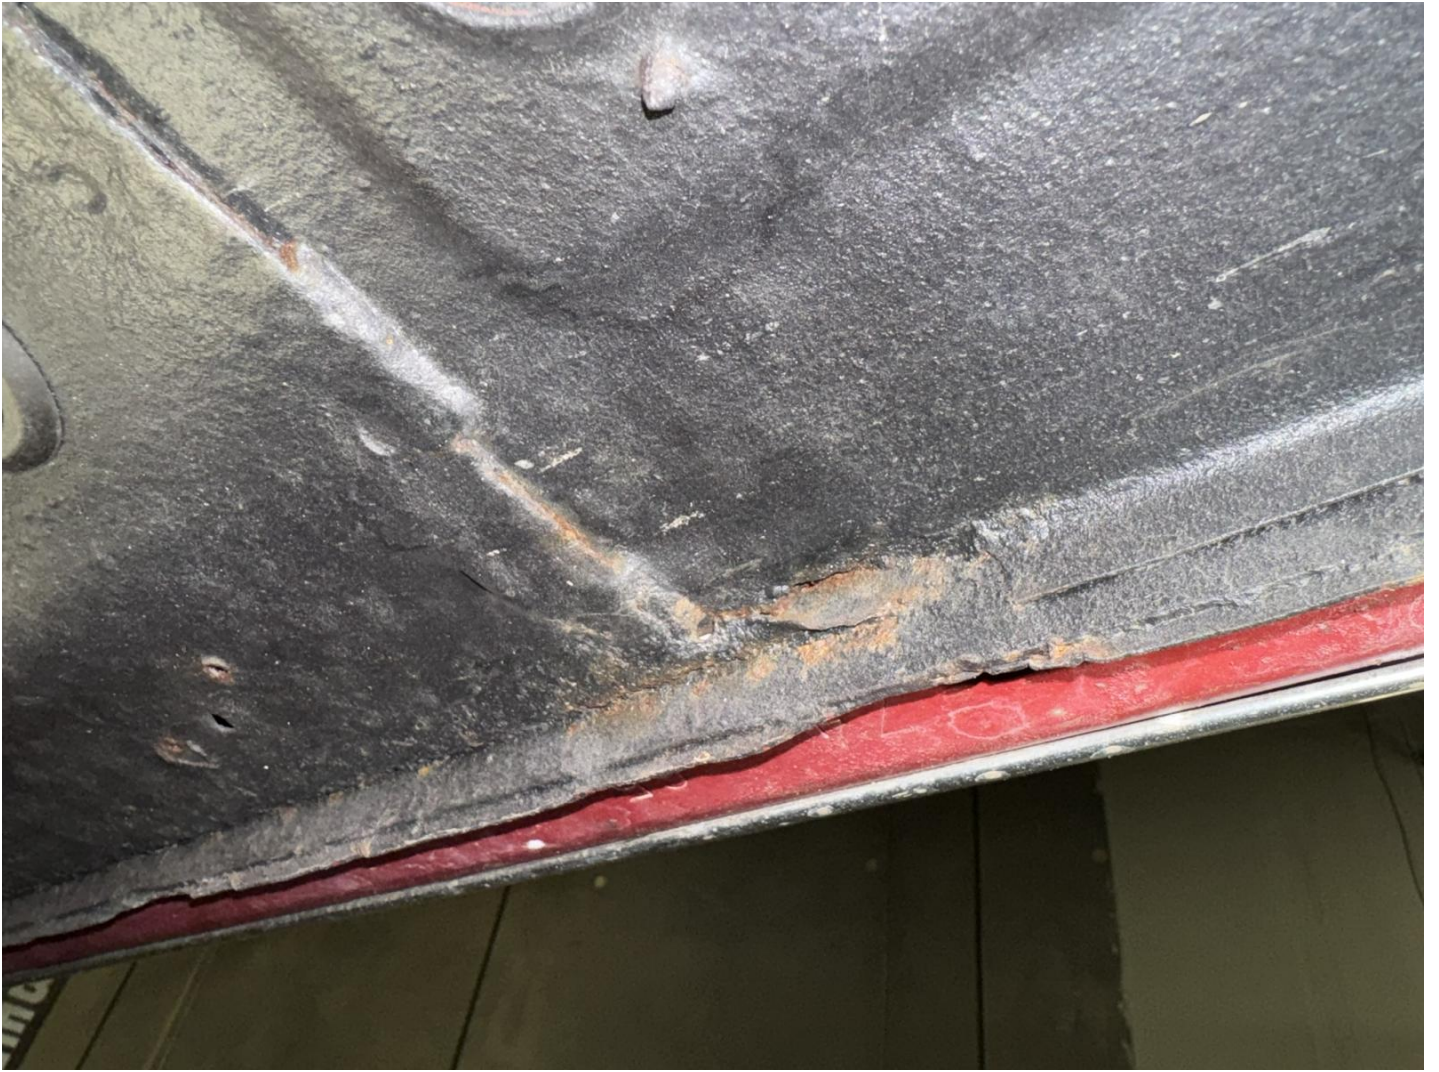
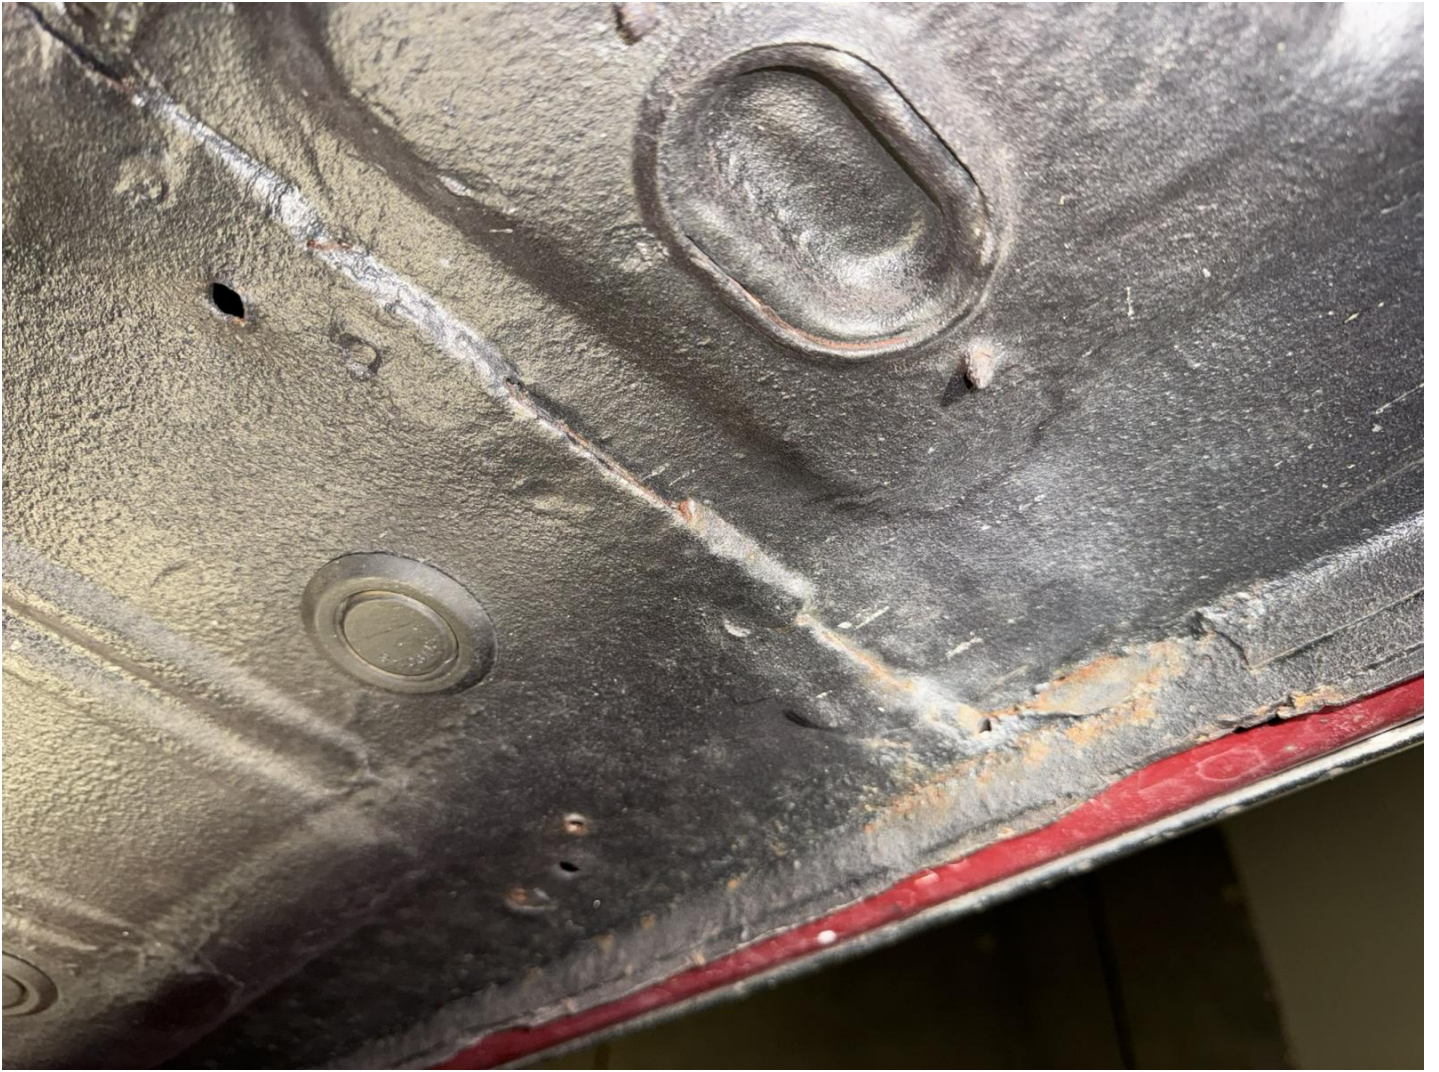
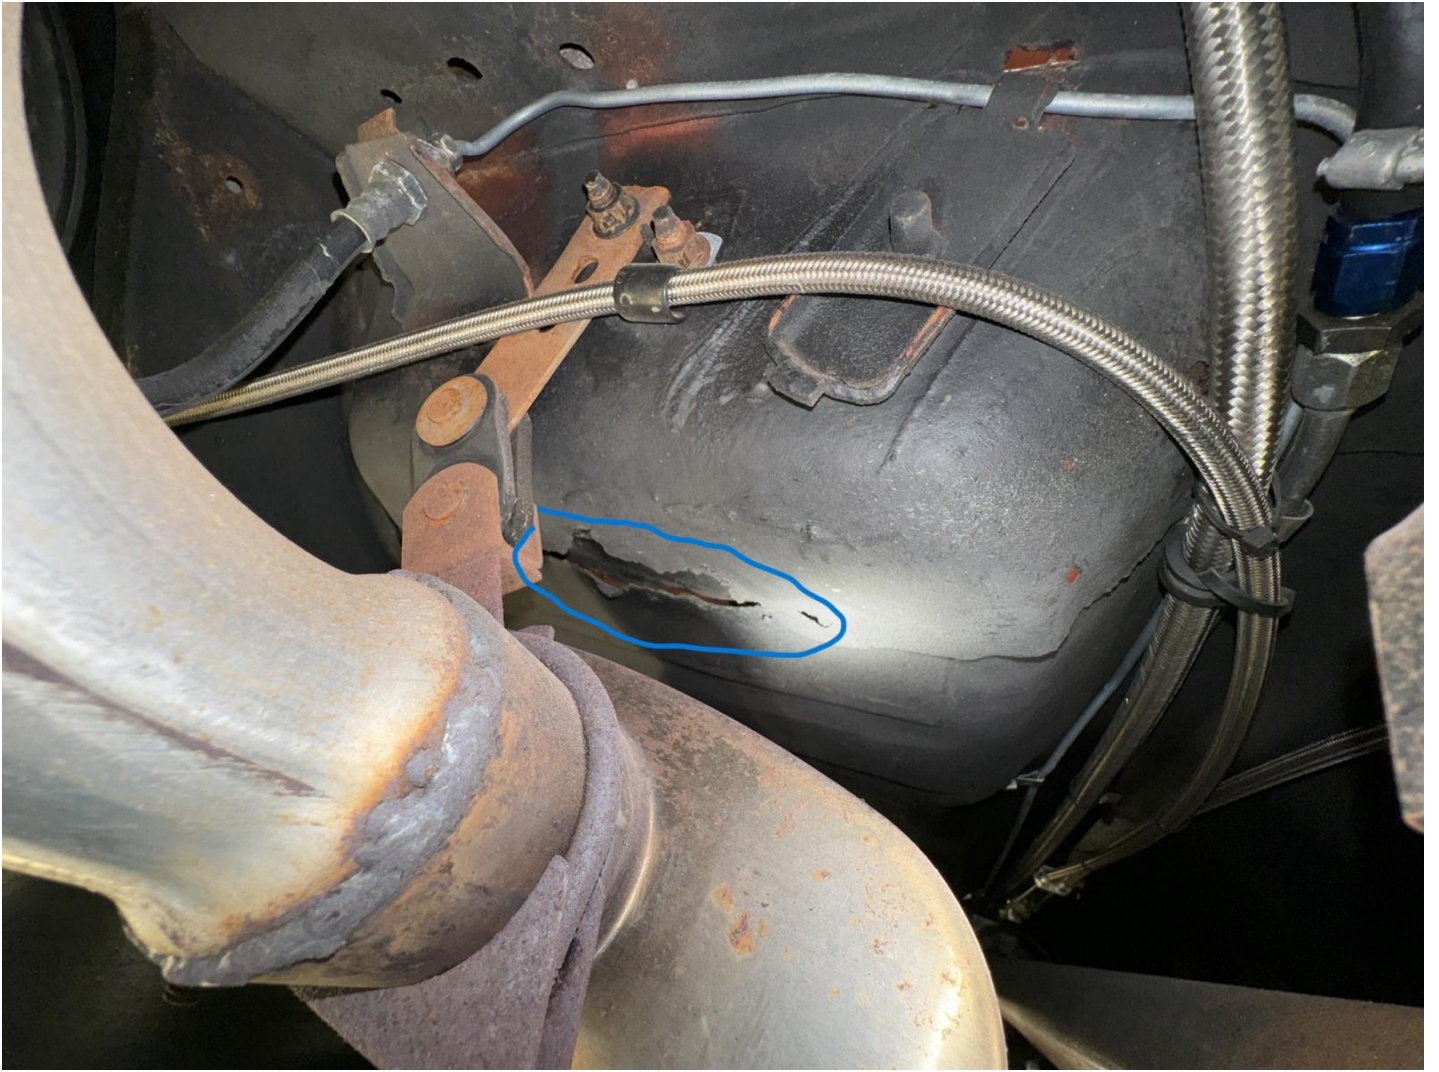
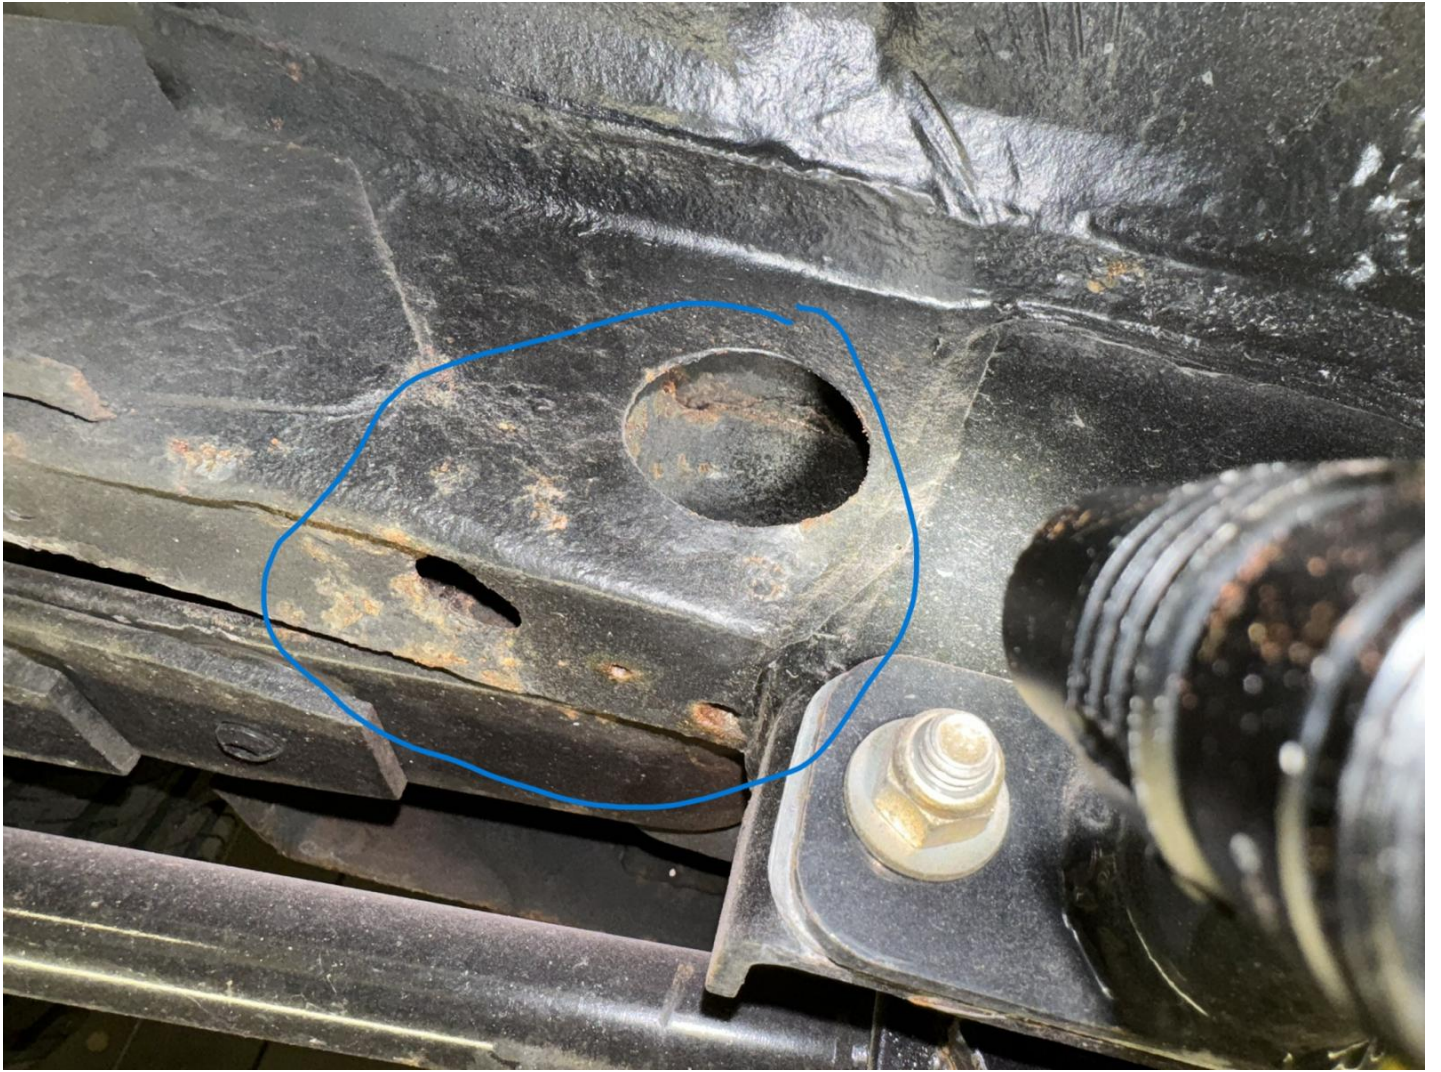
Significant corrosion Holes in the bottom (some were patched), rusted rear rails. Corrosion in the trunk.
