1968 Ford Mustang

Summary

Inspection date: Jan 10 2024
CarAdvisors — Metro Atlanta, GA

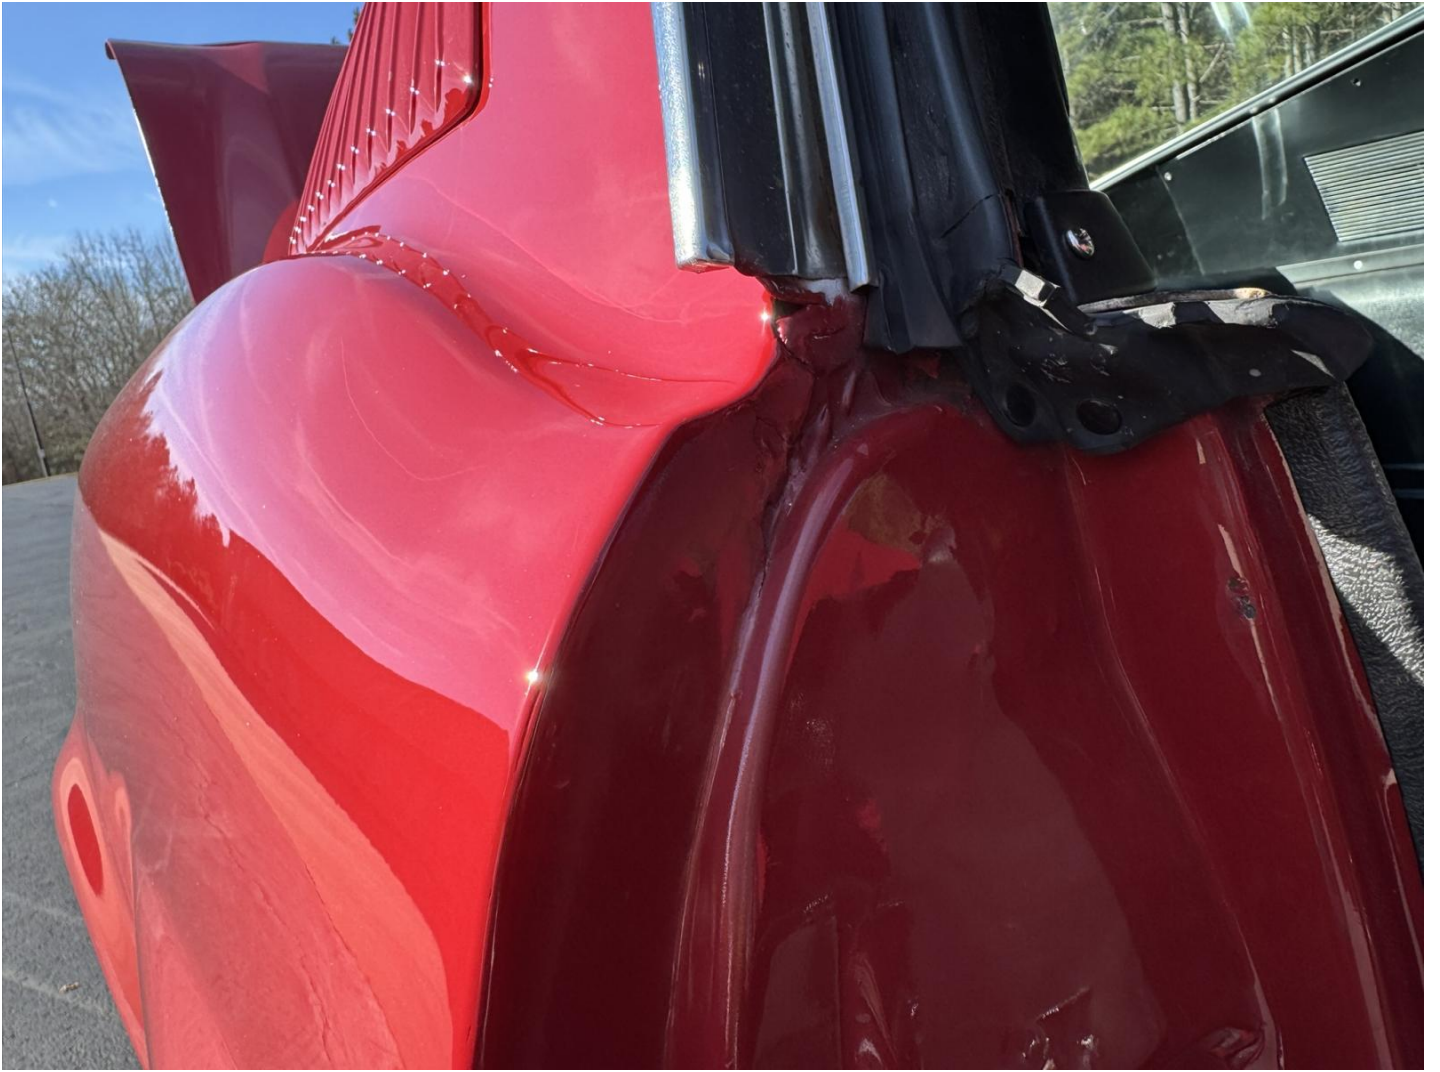
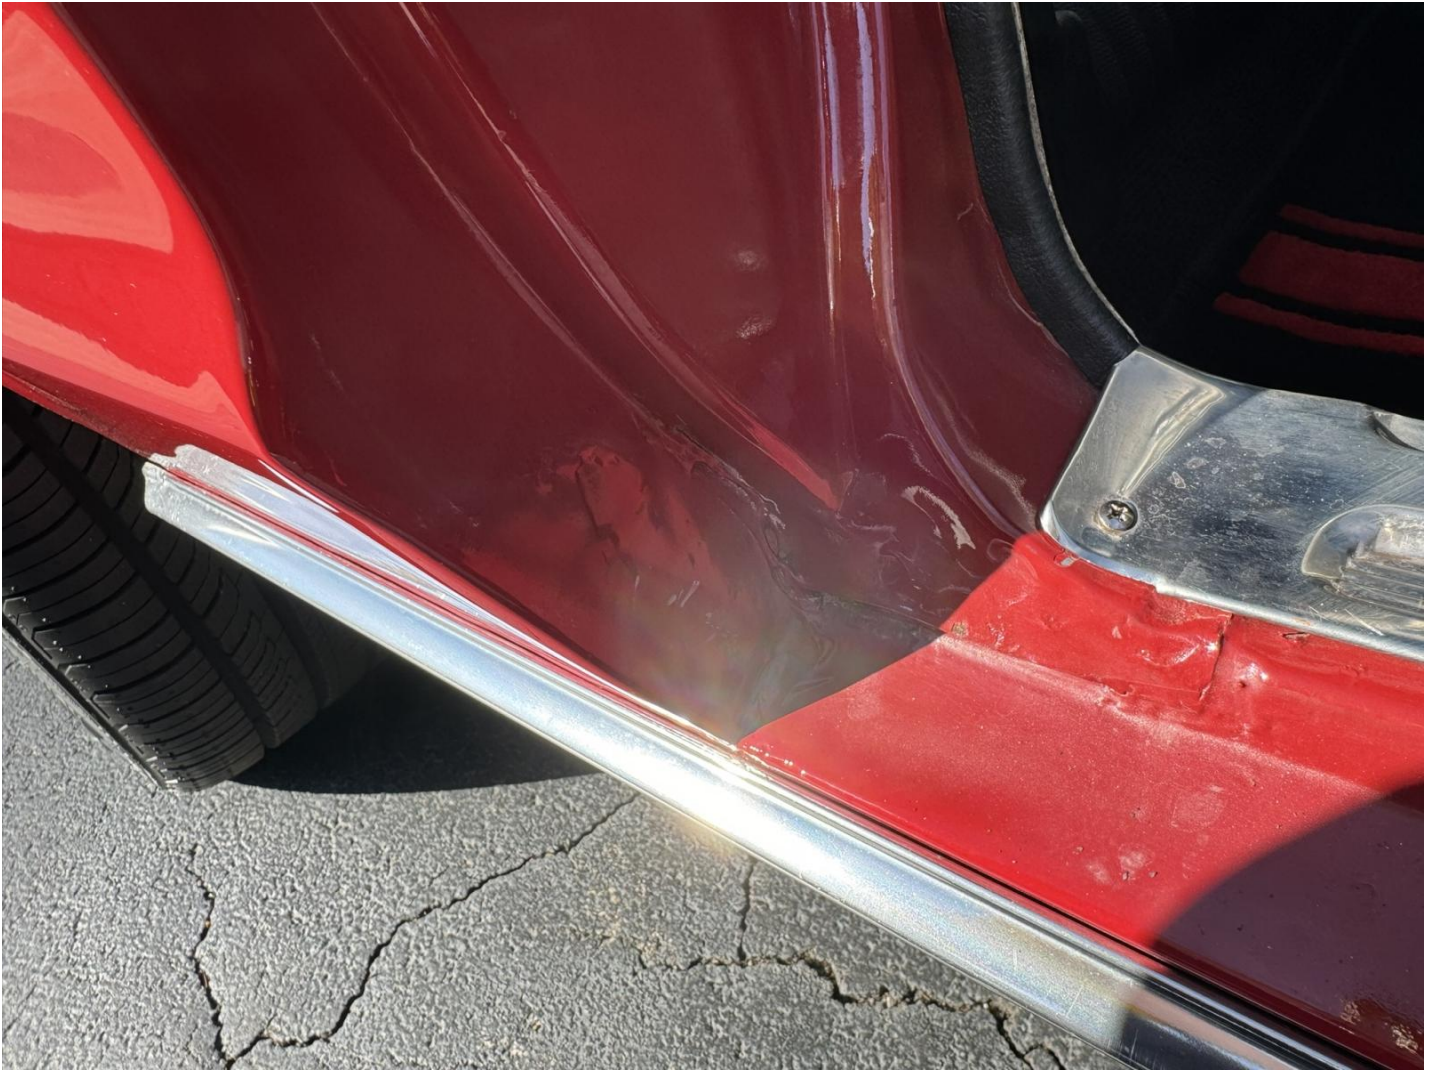
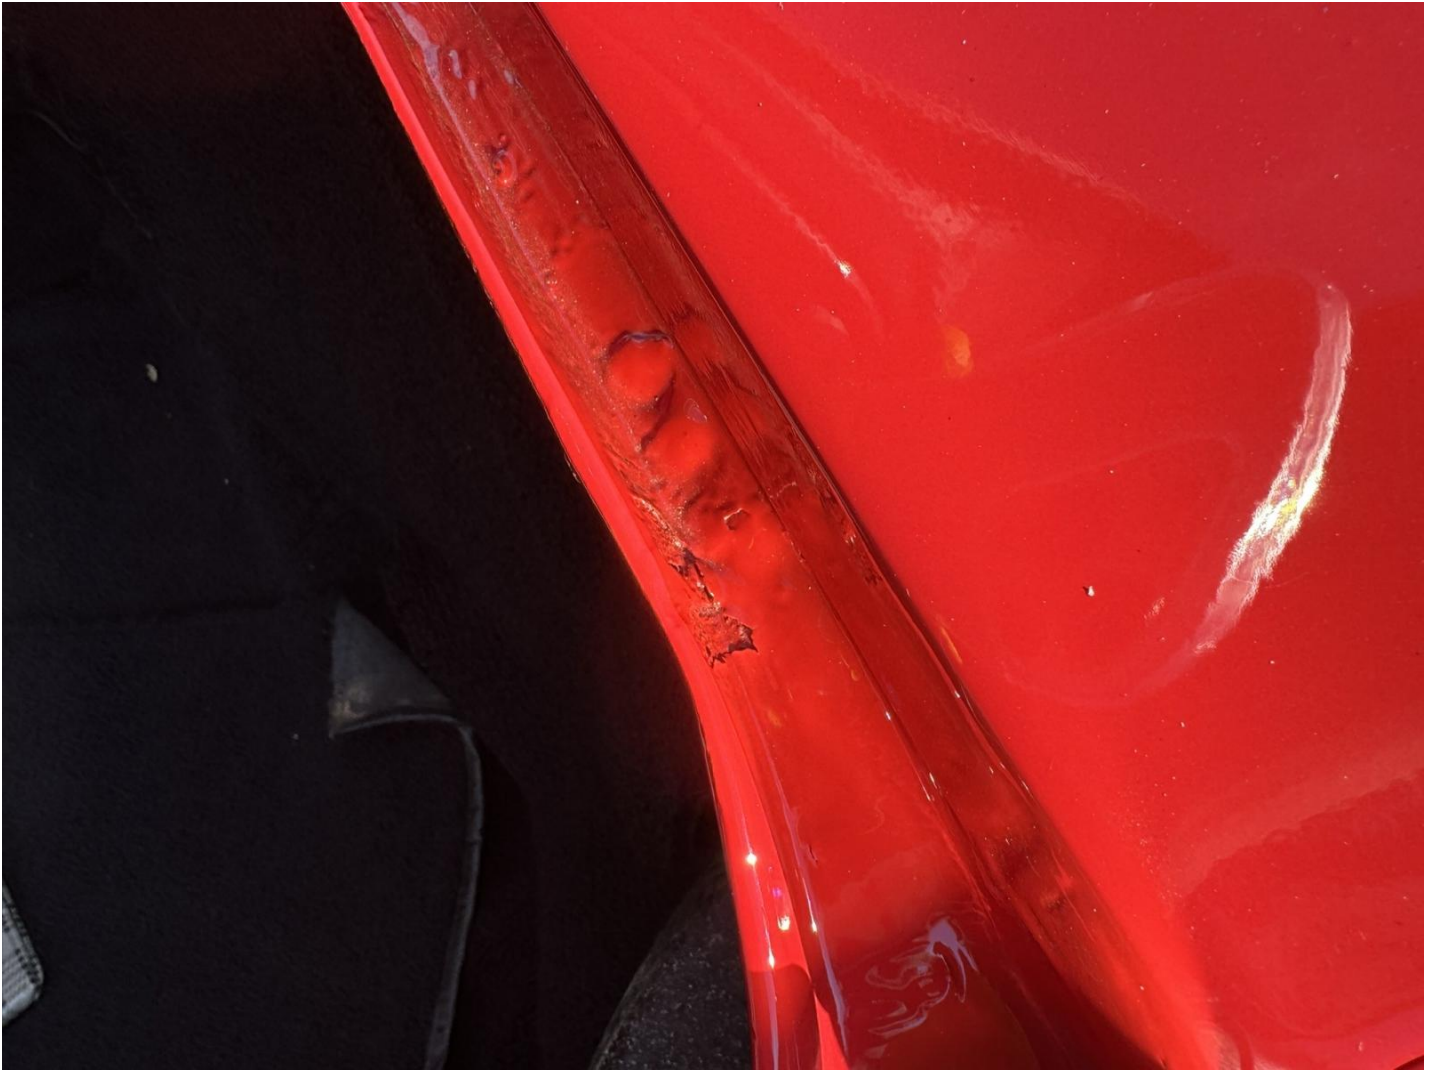
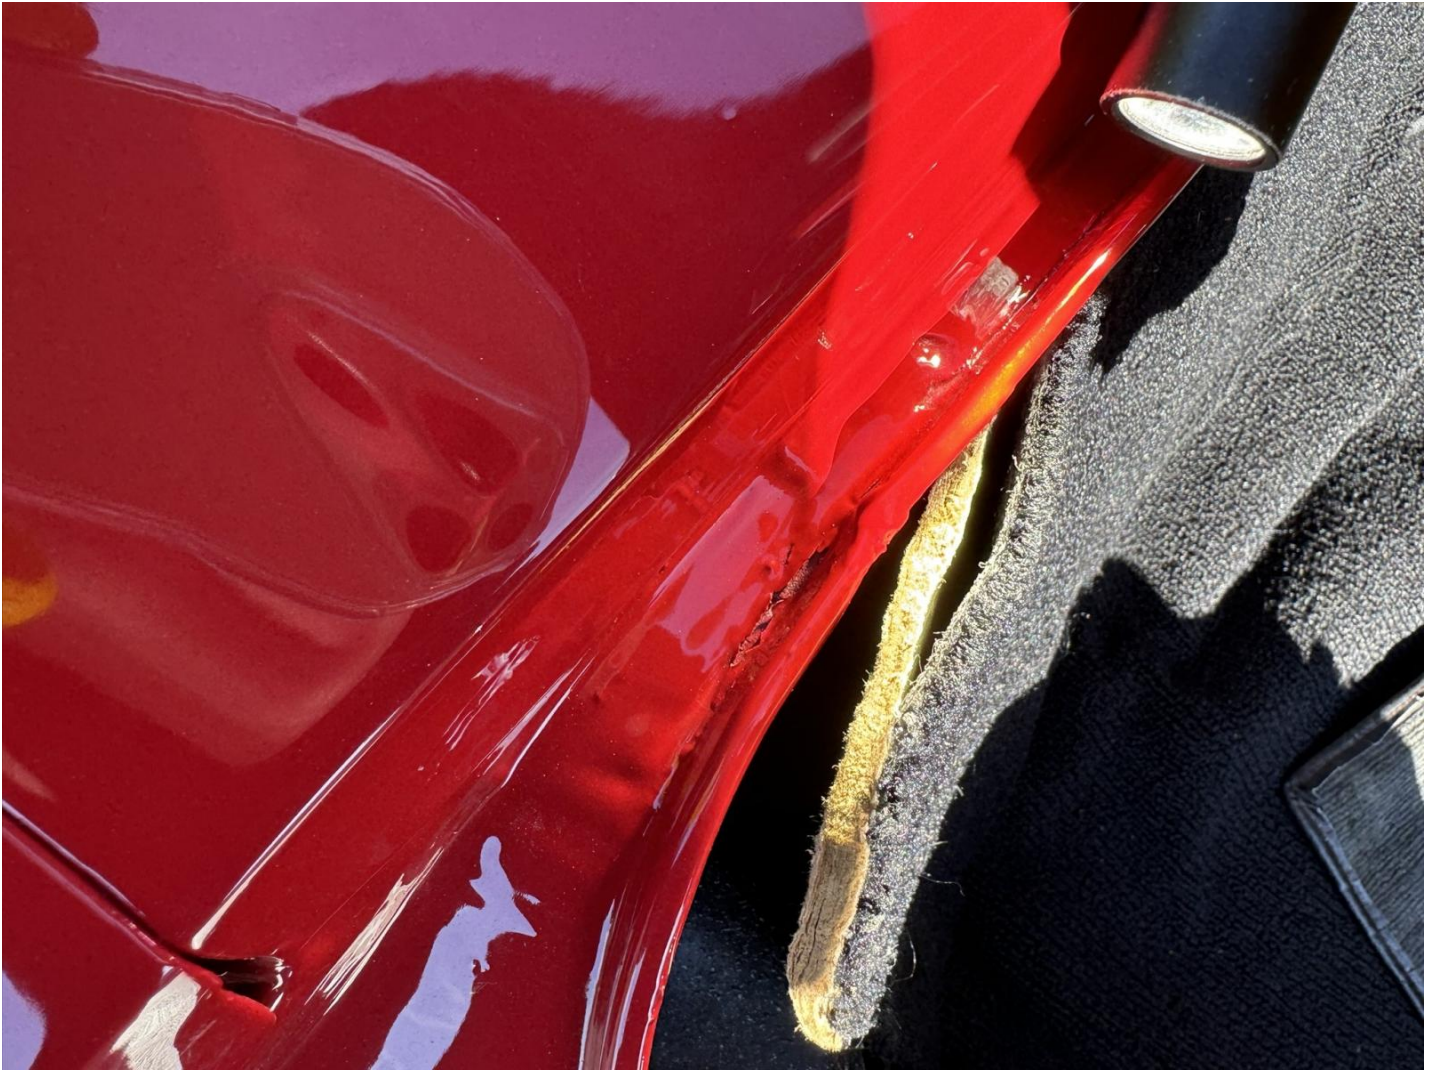
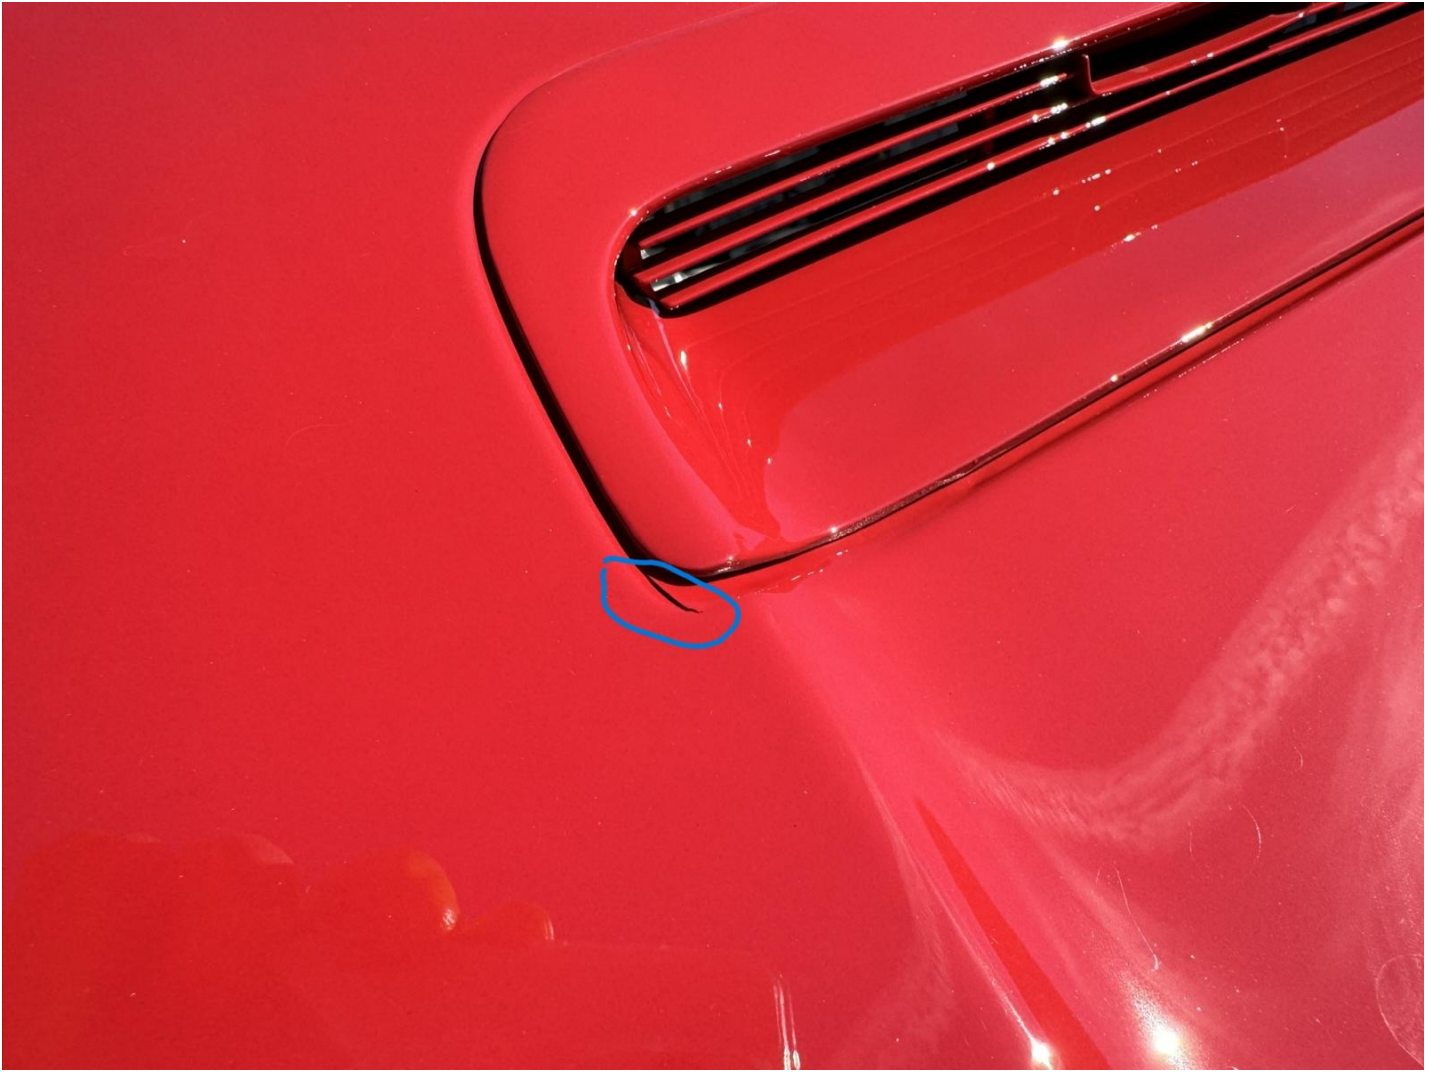
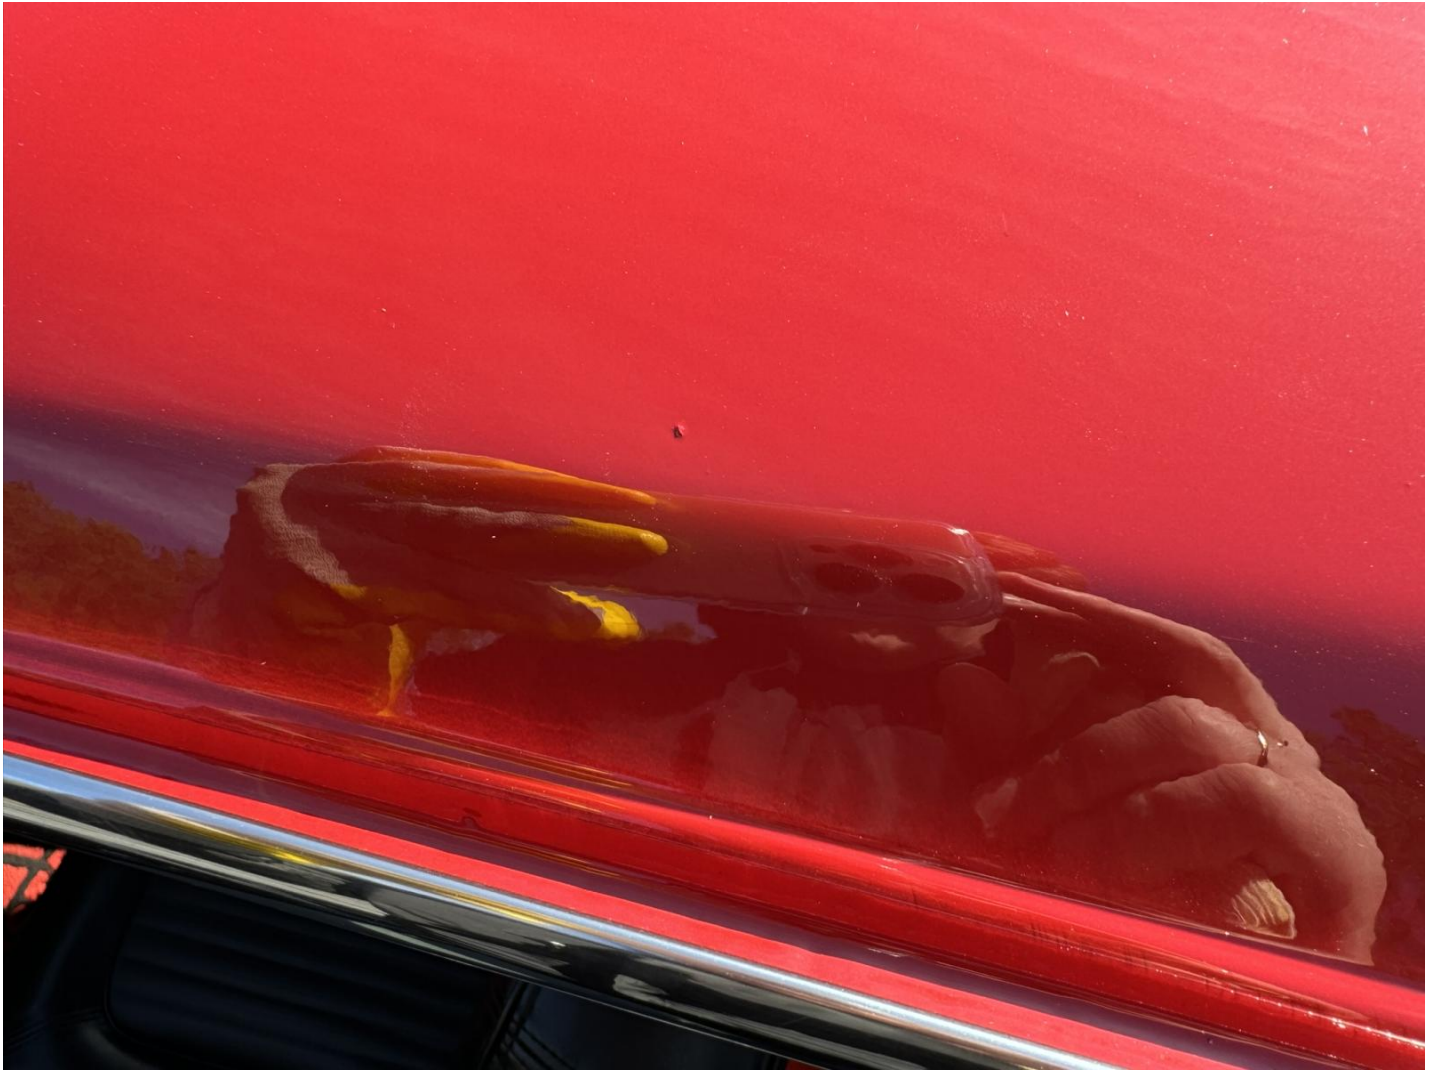
Entire car repainted The body was entirely repainted a few times. The paint job is decent: some dust in the paint, orange peel.

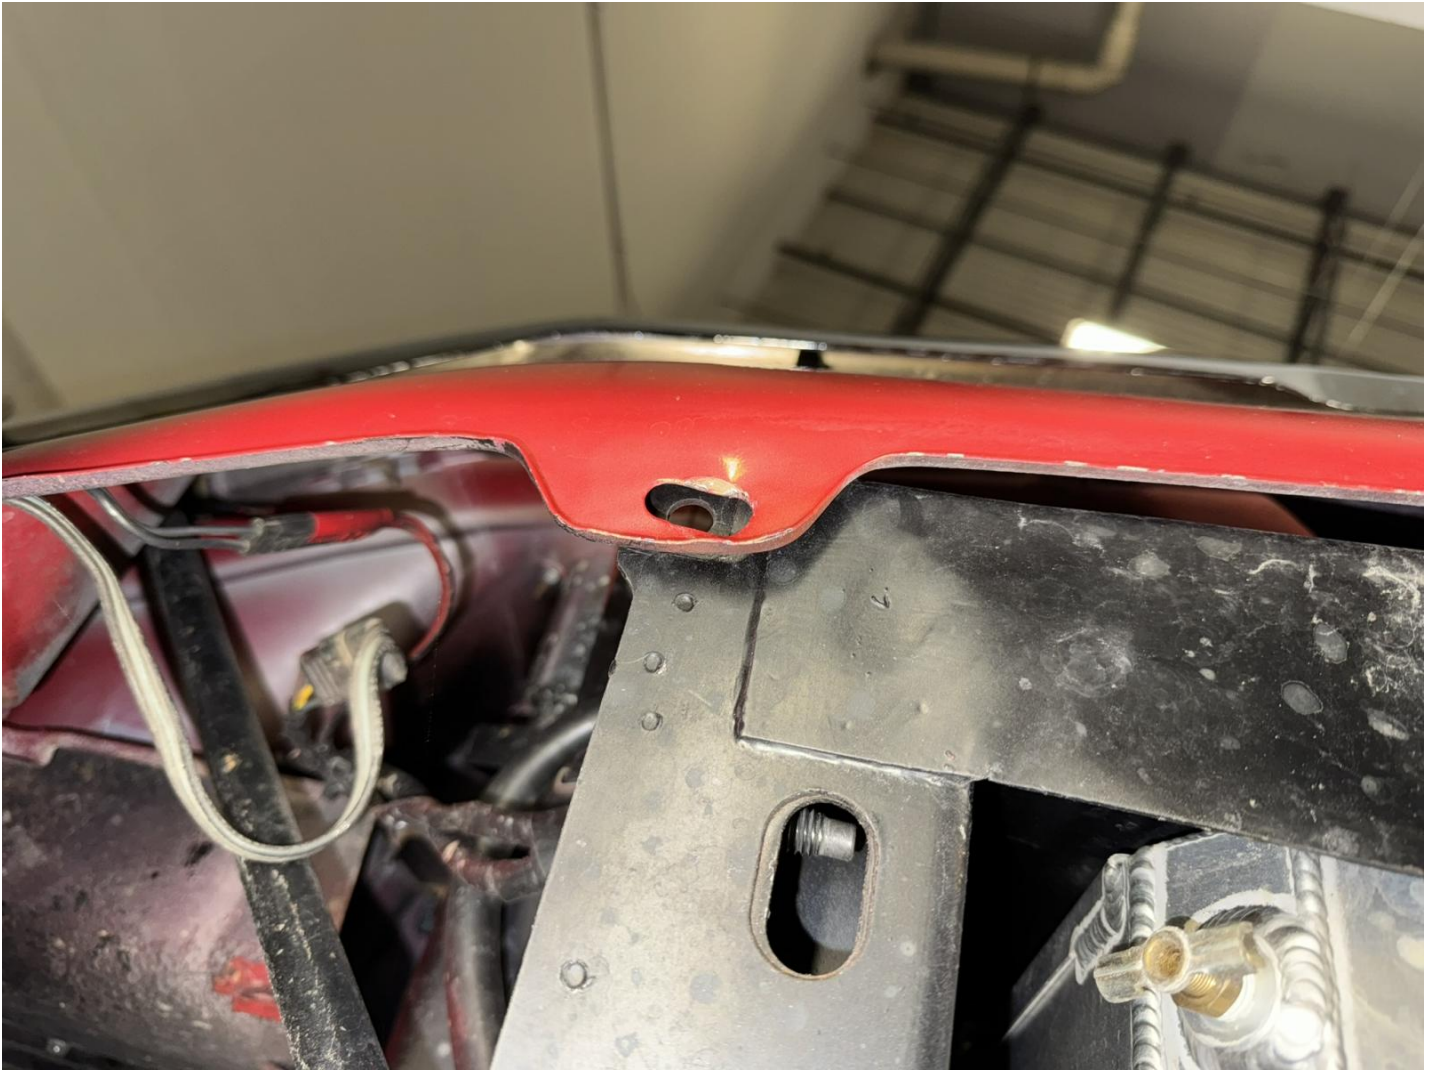
Body damage: Radiator grille

Location	Damage
Radiator grille	missing bolts
Rear bumper	uneven gaps
Trunk lid	uneven gaps
Rear windshield	uneven gaps
Front right fender	scratched
Right quarter panel	scratched

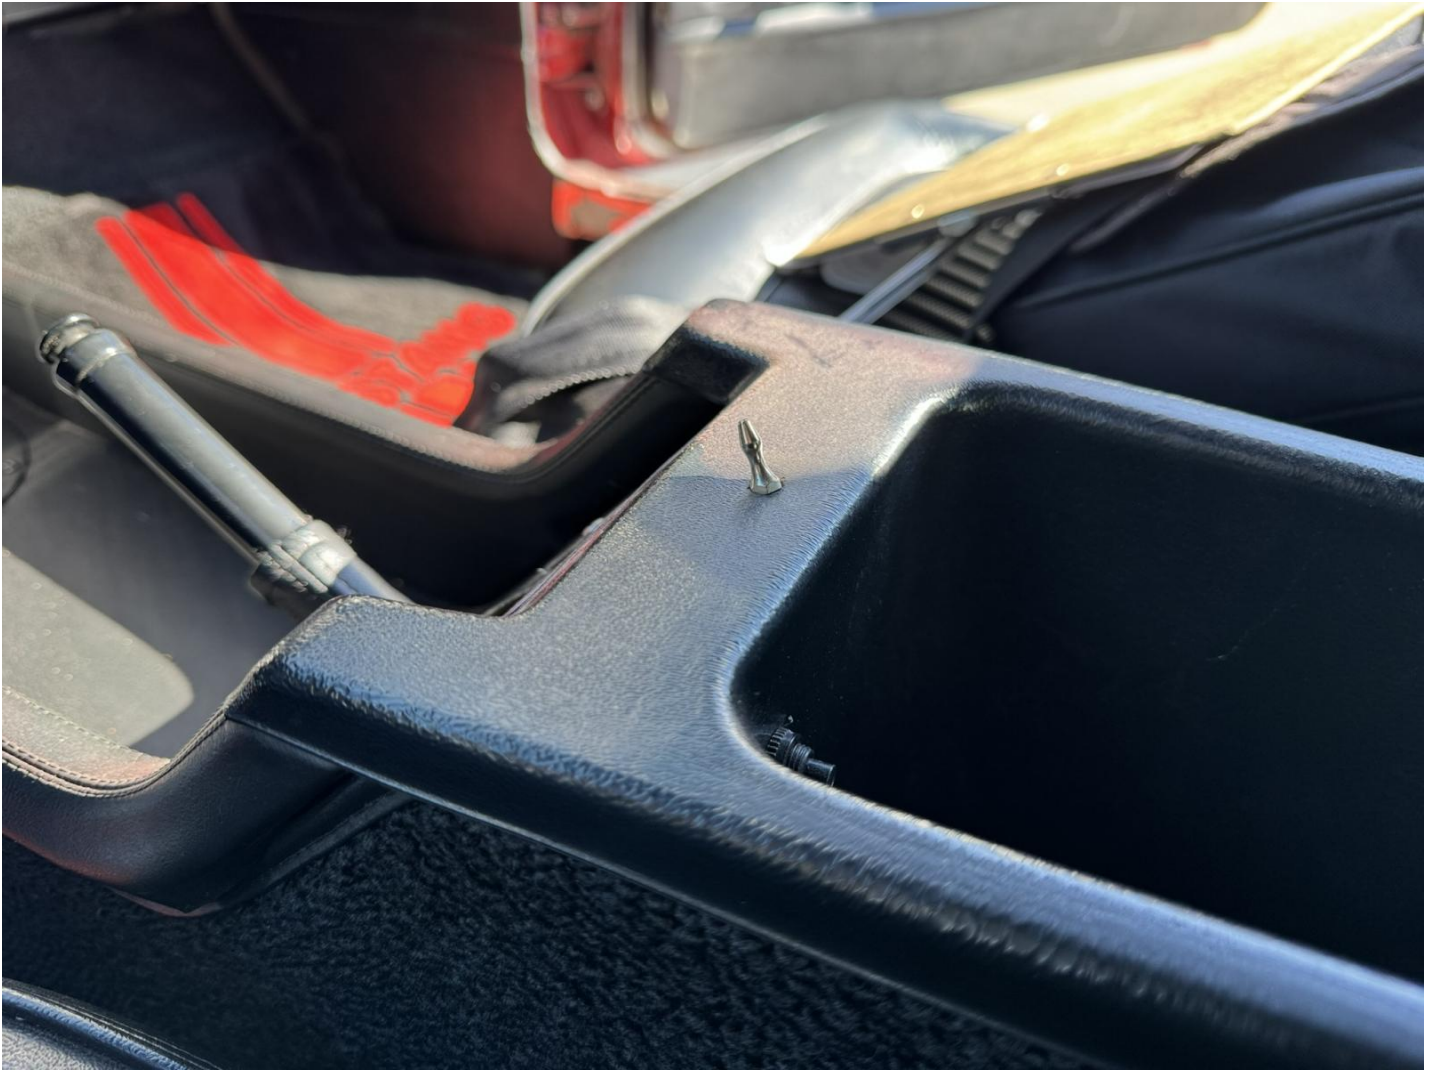
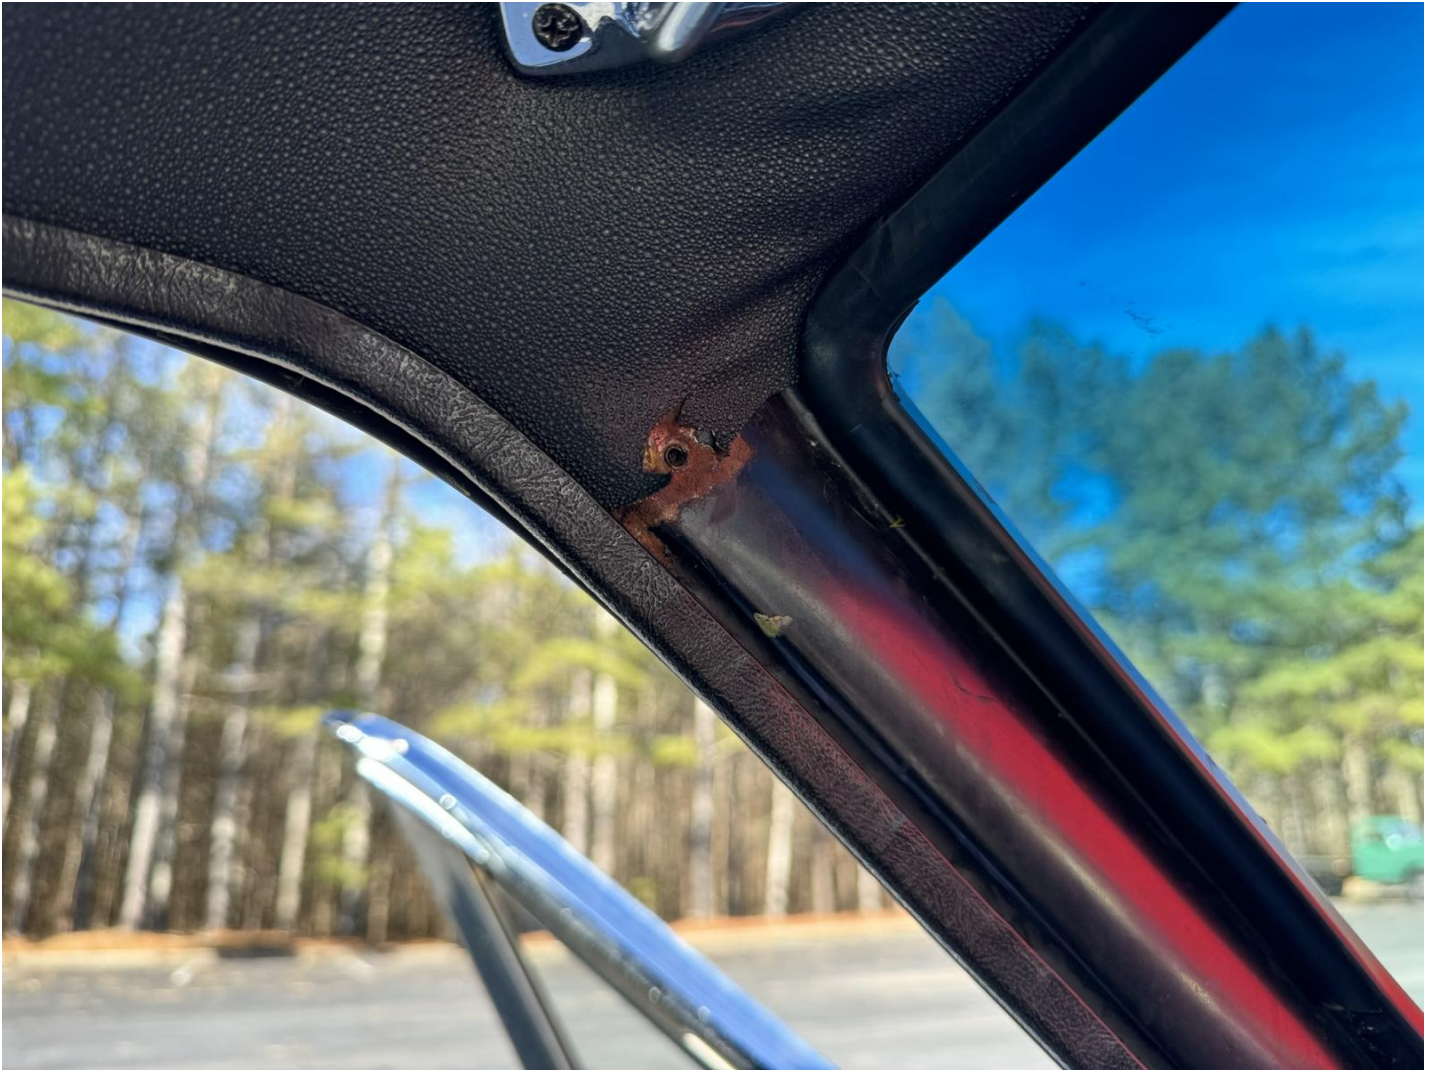
Interior - damaged parts

Interior damages		1 issue
Noticeable dirt	no	
Worn out parts	no	
Unusual odor	no	
Damaged parts	missing left headliner edge trim, the central box doesn't lock	
Water leaks	no
