1968 Ford Mustang

Summary

Inspection date: Jan 10 2024
CarAdvisors — Metro Atlanta, GA

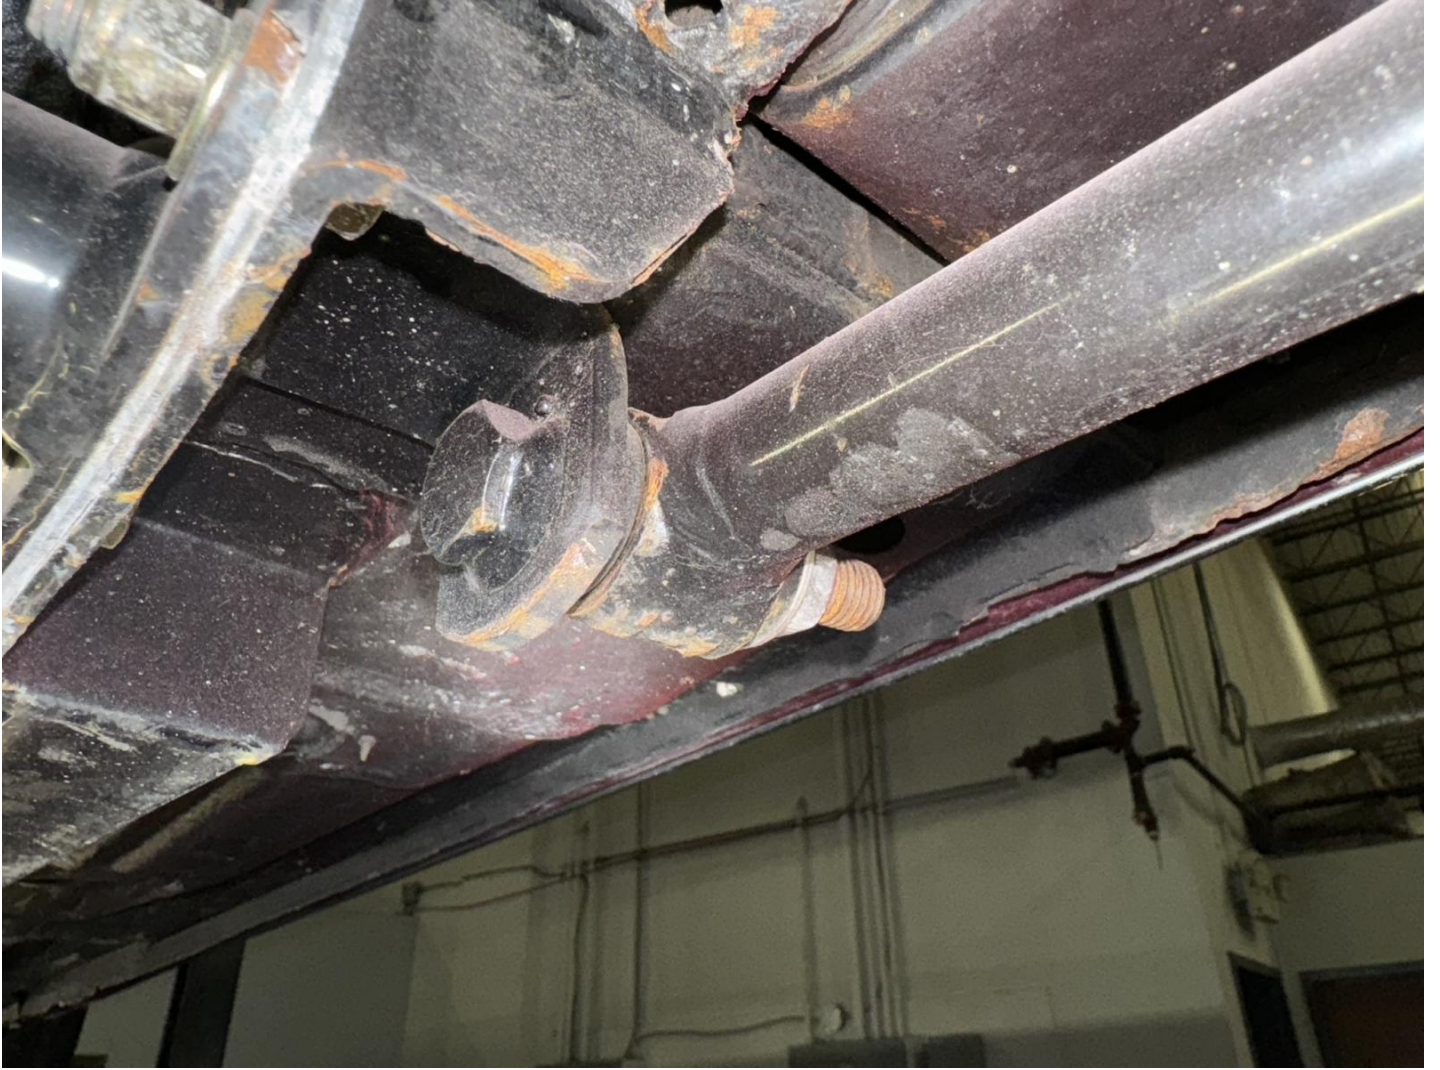
Joints (visual control)	non factory rear control arms, broken pin weld on the left side
-------------------------	---

cracked weld

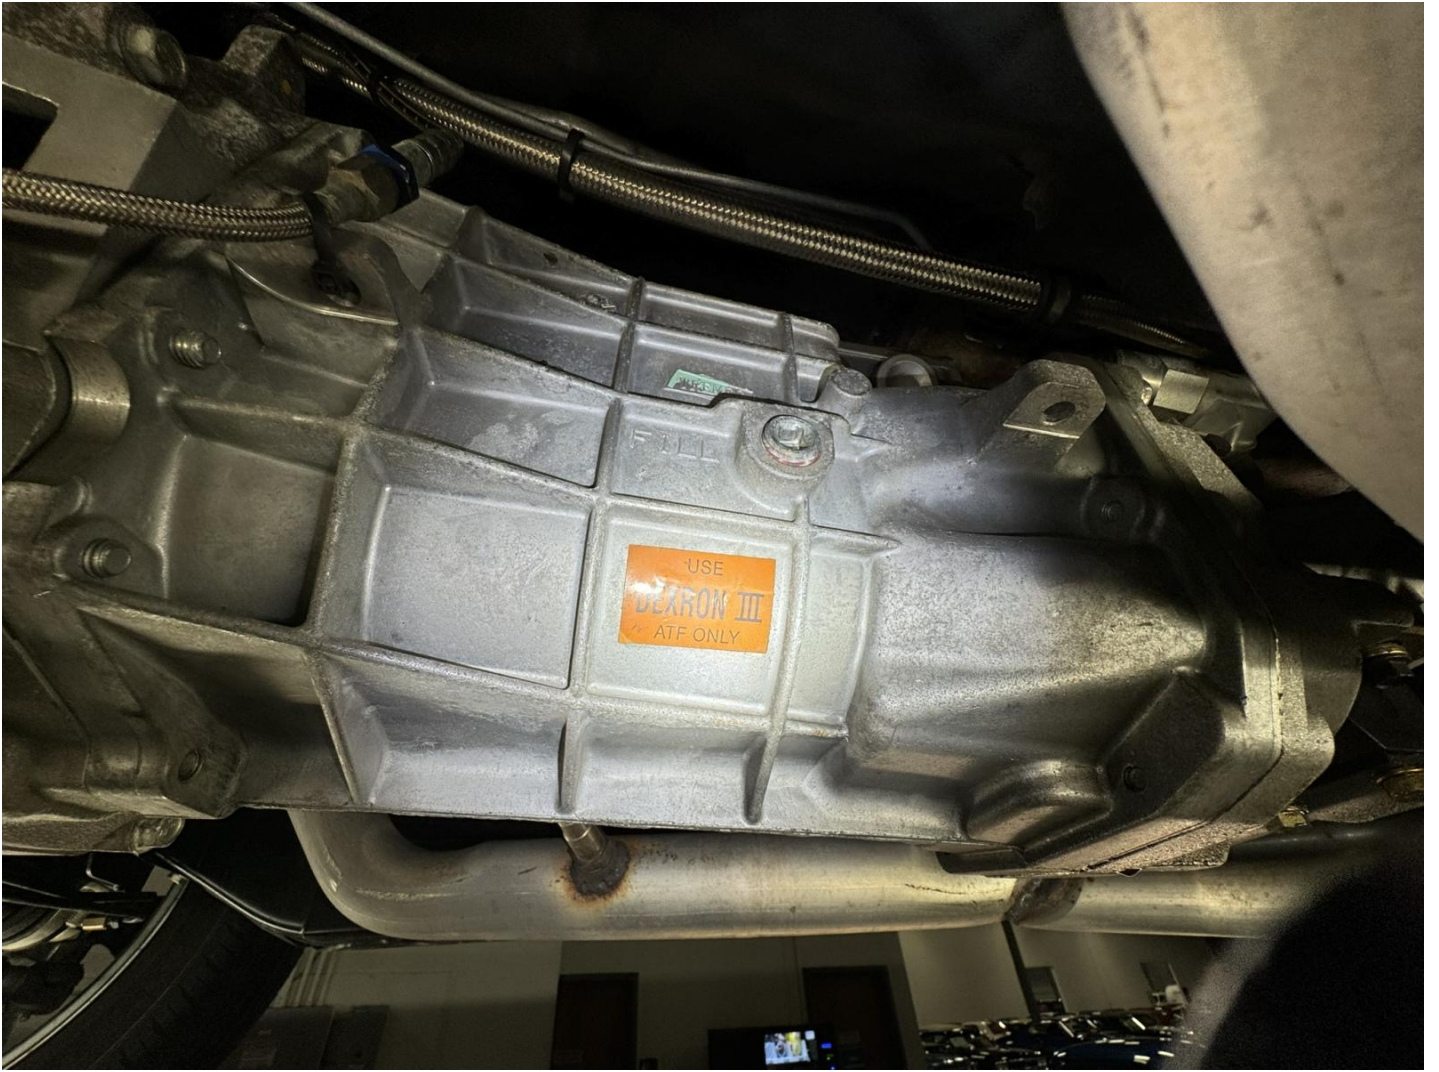
Mechanically the engine runs well with clean oil and no abnormal noise, but there is an oil leak from the valve cover gaskets. This is a common, relatively minor leak, but left unattended oil can drip and create a mess or fire risk near hot components, so it should be resealed. There is also oil residue on the transmission housing and an active leak from the rear differential — these should be monitored and resealed to avoid running components low on fluid over time. The clutch feels too stiff, which can point to worn linkage or hydraulic/cable wear and should be checked for comfort and reliability.

valve cover oil leak

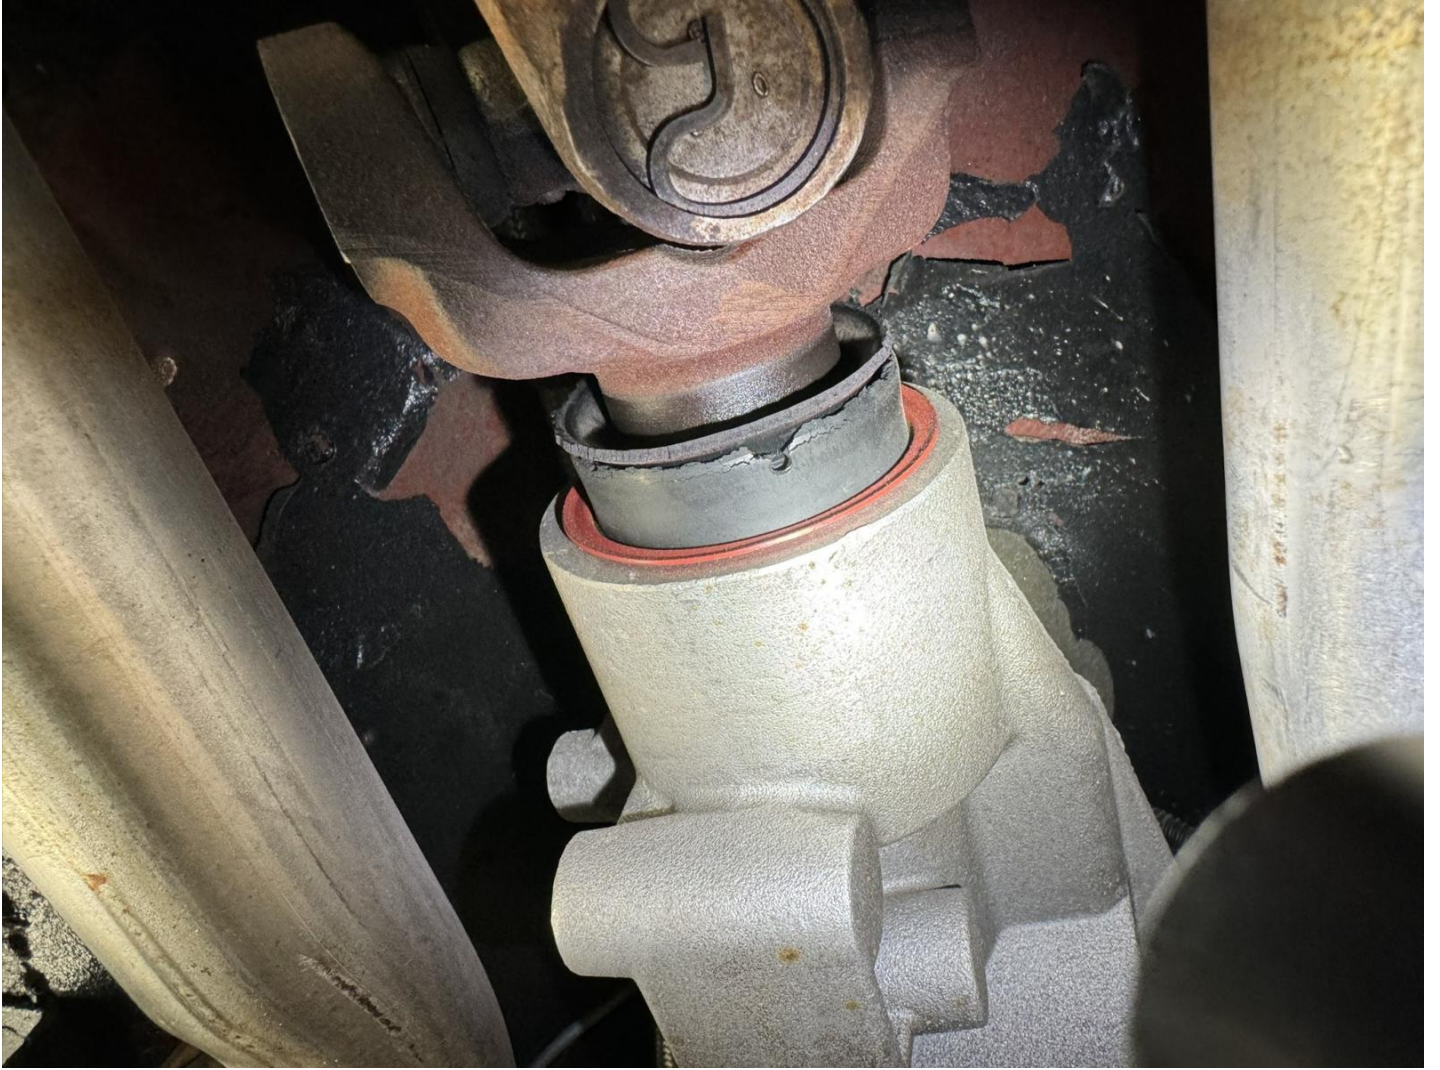
Abnormal Noise	no
Synchronizers	ok
Clutch	too stiff
Shifting force	normal
Oil leaks	oil residue on the transmission housing
Sings of recent repairing	not found

transmission oil leak

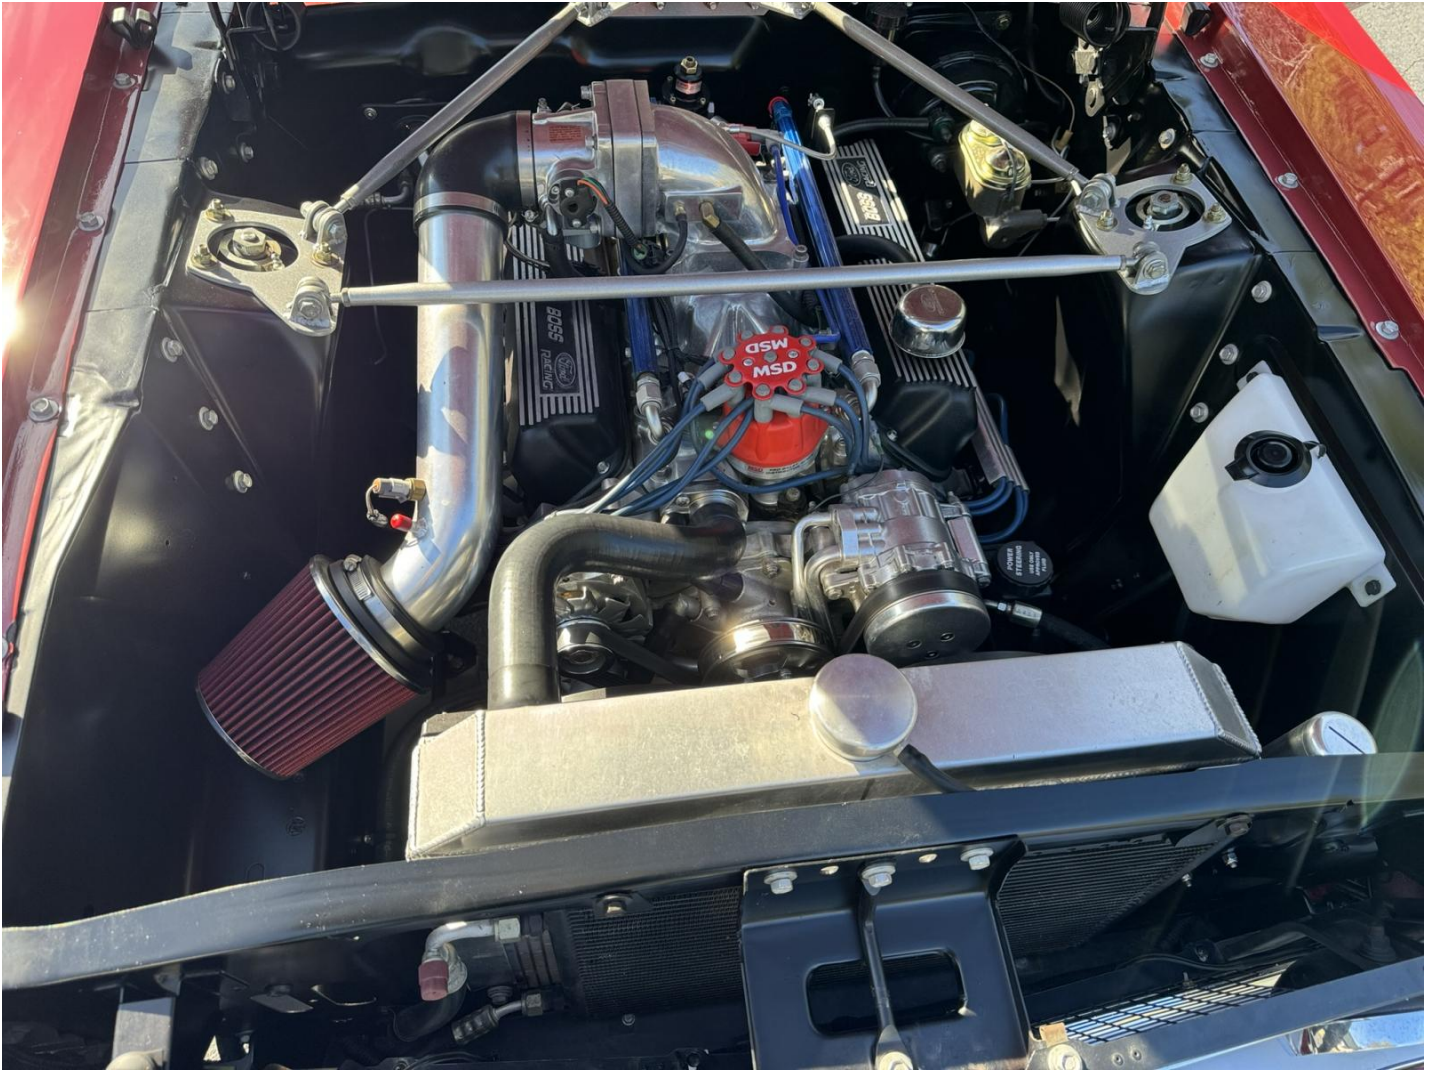
loose wires
